# HOGAN FOUNTAIN AREA MASTER PLAN

FOR  
THE OLMSTED PARKS CONSERVANCY  
AND  
LOUISVILLE METRO PARKS

DECEMBER 2010

BY  
ENVIRONS INC. LANDSCAPE ARCHITECTS  
HERITAGE LANDSCAPES, LLC  
MATTINGLY ENGINEERS, LLC  
STUDIO KREMER ARCHITECTS

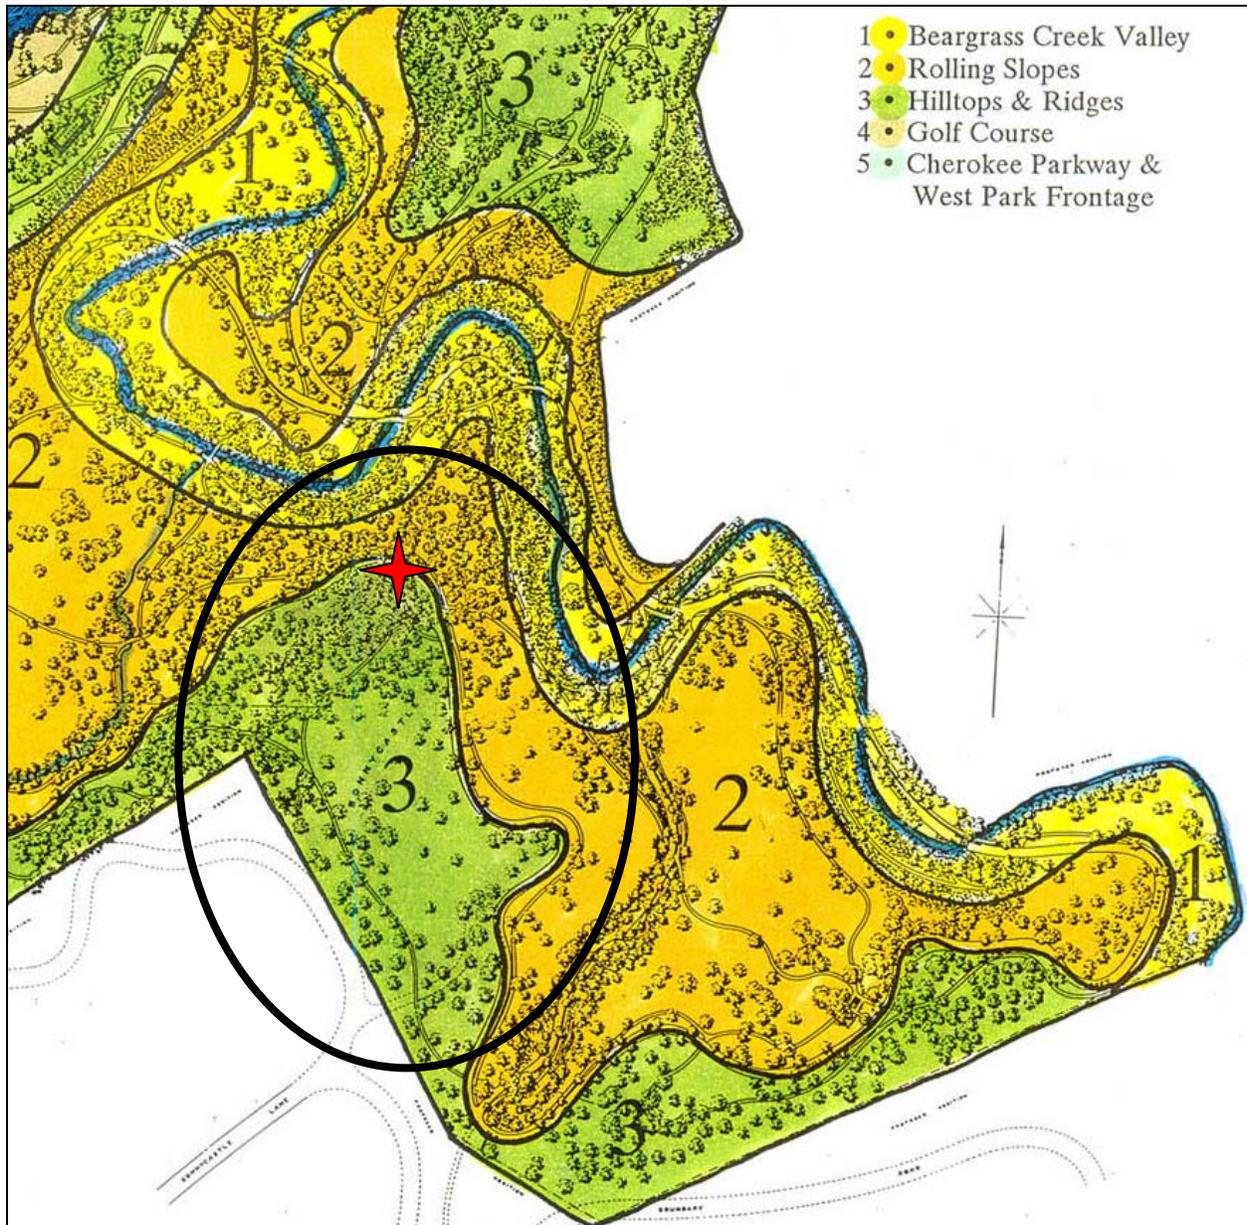
Figure 1: This figure shows the General Plan with an overlay of the historic zones of Cherokee Park. Bonnycastle Hill is an important hilltop in the rolling Beargrass Creek valley that is at the core of the Hogan Fountain project area. The slopes rolling down to Beargrass Creek are to the east of the hill. The park drive traverses the slope near the hilltop to provide site access. Hogan Fountain is positioned at the north turning of the drive noted by the red star. The approximate project area is highlighted by the black oval. (THL-Cherokee-GeneralPlan-Overlay-Hogan-Bonnycastle.jpg)

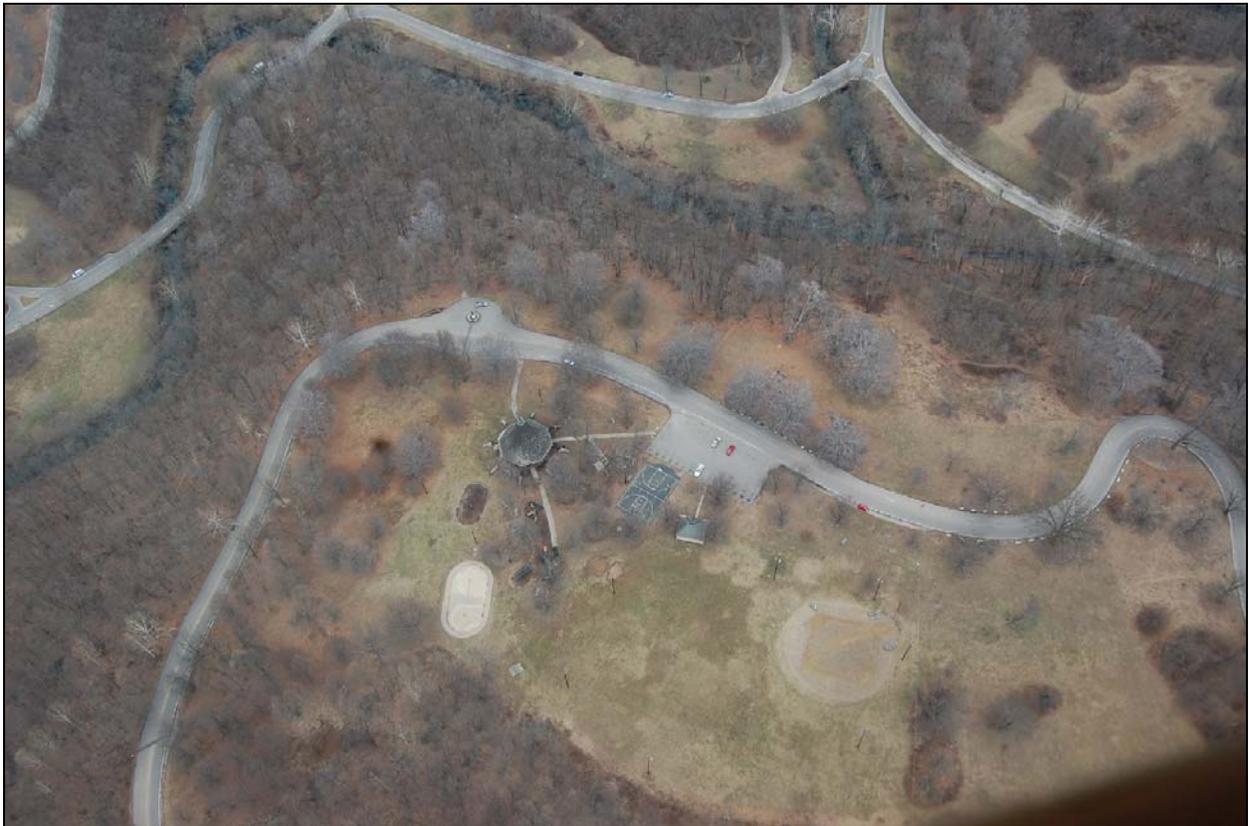
Figure 2: The spatial organization of Hogan Fountain within Cherokee Park is seen in this 2009 aerial photograph. The Scenic Loop winds through the landscape, dividing landscape Units 1 and 2. Unit 1, Bonnycastle Hill, is an open, rolling hilltop positioned to the west (the bottom of the frame in this image). Unit 2, Hogan Fountain, Drive & Open Slopes, is located east of Unit 1, across the Scenic Loop. Unit 3, Woodland Slopes & Trails is a densely vegetated landscape that encloses Units 1 and 2 in all directions. (Hogan Fountain aerial February 2009.jpg)

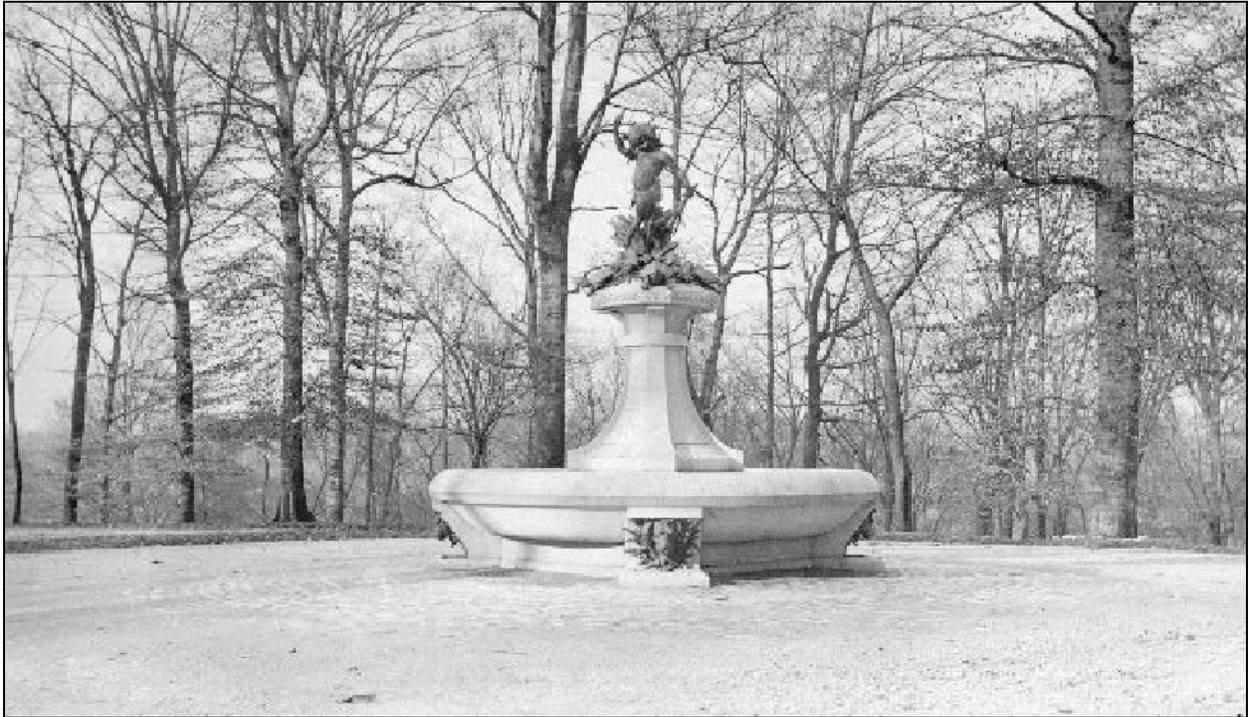
Figure 3: This early 20th century view of Hogan Fountain provides documentation of the open area around this sculptural and functional work with the sunlit overlook and the open woodland downslope. (THL-Hogan Fountain-Historic-Cobbles-UL529.jpg)

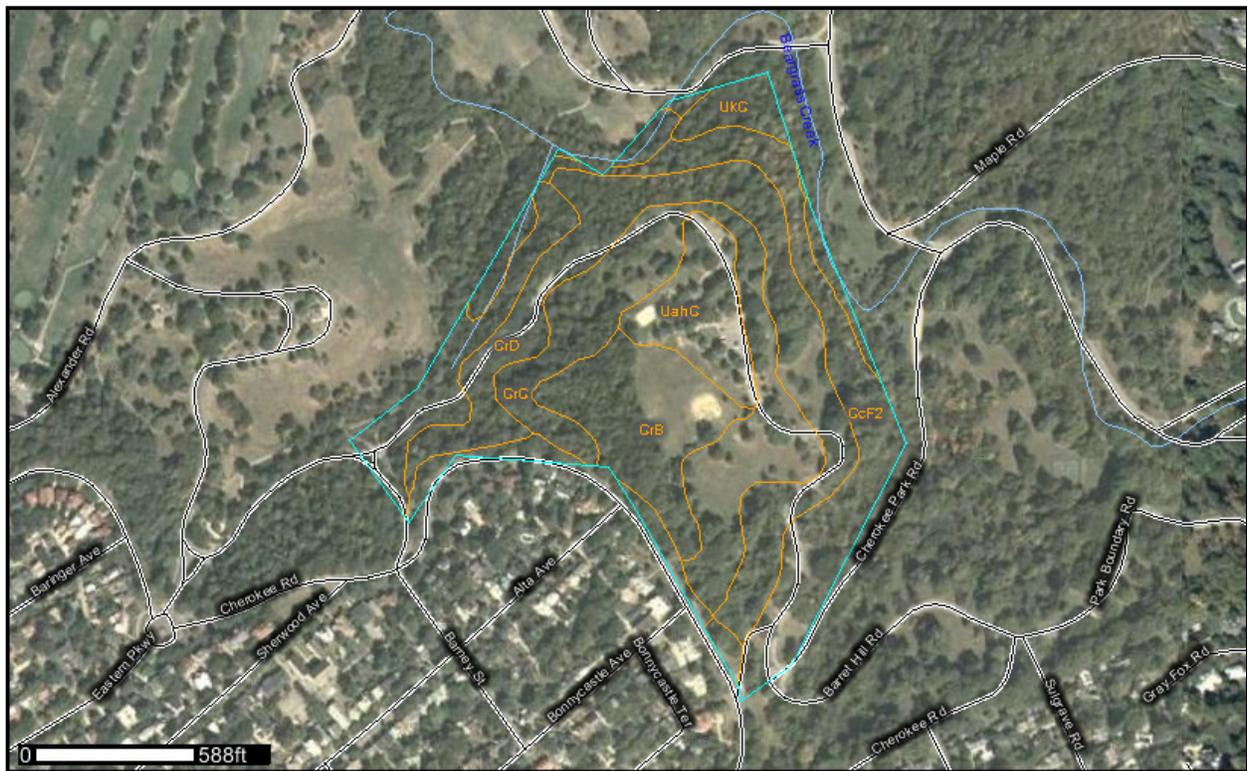
Figure 1. Portion of the NRCS Jefferson County Soils Map

According to the Natural Resources Conservation Service Soil Survey of Jefferson County, Kentucky, the site is primarily underlain by soils that belong to the Crider series (CrB, CrC, CrD) and the Urban Land-Udorthents complex (UahC) at the upper elevations and the Caneyville rock outcrop complex (CcF2) at the lower elevations. The Crider soils are generally described as fine silty loess over clayey residuum weathered from the parent limestone. The Caneyville rock outcrop is described as clayey residuum weathered from shallow limestone. No description was provided for the Urban Land Udorthents Complex.

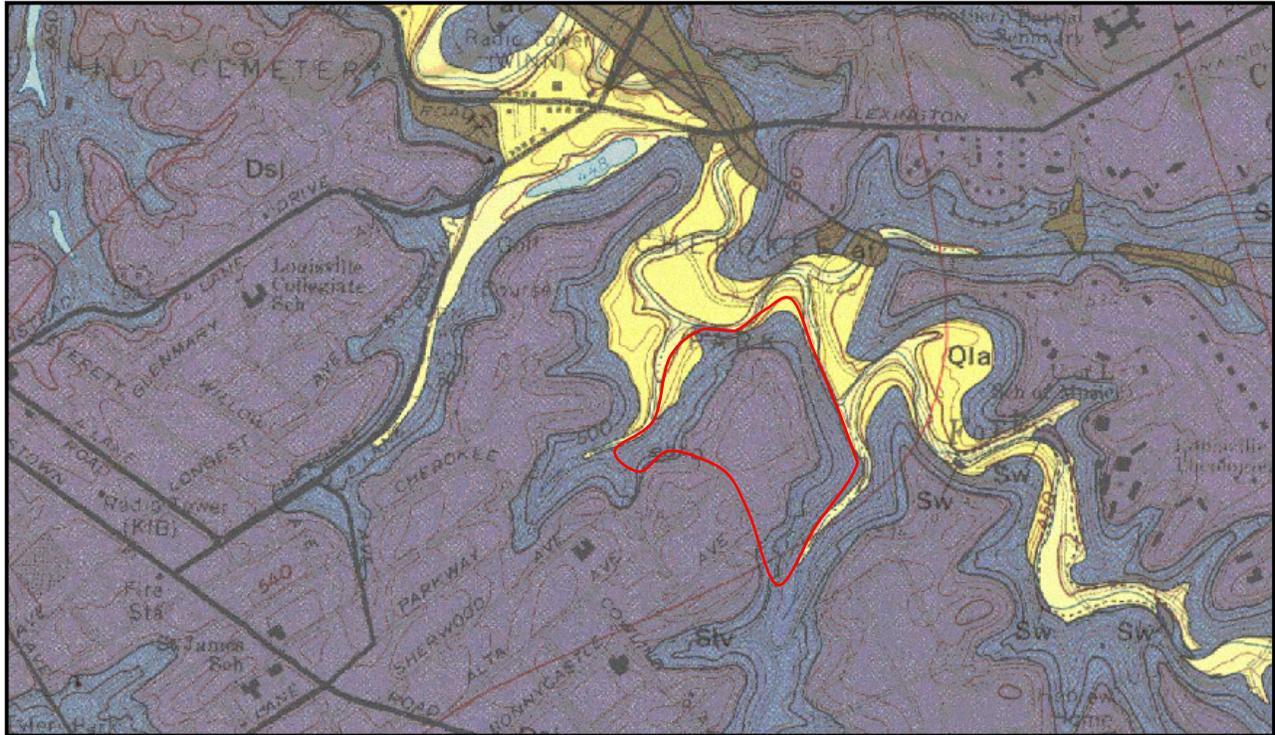
**Figure 2. Portion of the USGS Geologic Map of the Jeffersontown Quadrangle (1972)**

Based on a review of available geologic mapping (Geologic Map of the Louisville East Quadrangle, USGS, 1974), the site is primarily underlain by the Sellersburg and Jeffersonville Limestones (Dsj) at the upper elevations and Louisville Limestone (Slv) at the lower elevations. These limestone formations are described as being susceptible to dissolution and the subsequent development of karst features such as voids and sinkholes in the soil overburden, or voids in the underlying bedrock. Springs, such as Baringer Spring just to the southwest of the Hogan Fountain area, are common in the Sellersburg and Jeffersonville Limestone.

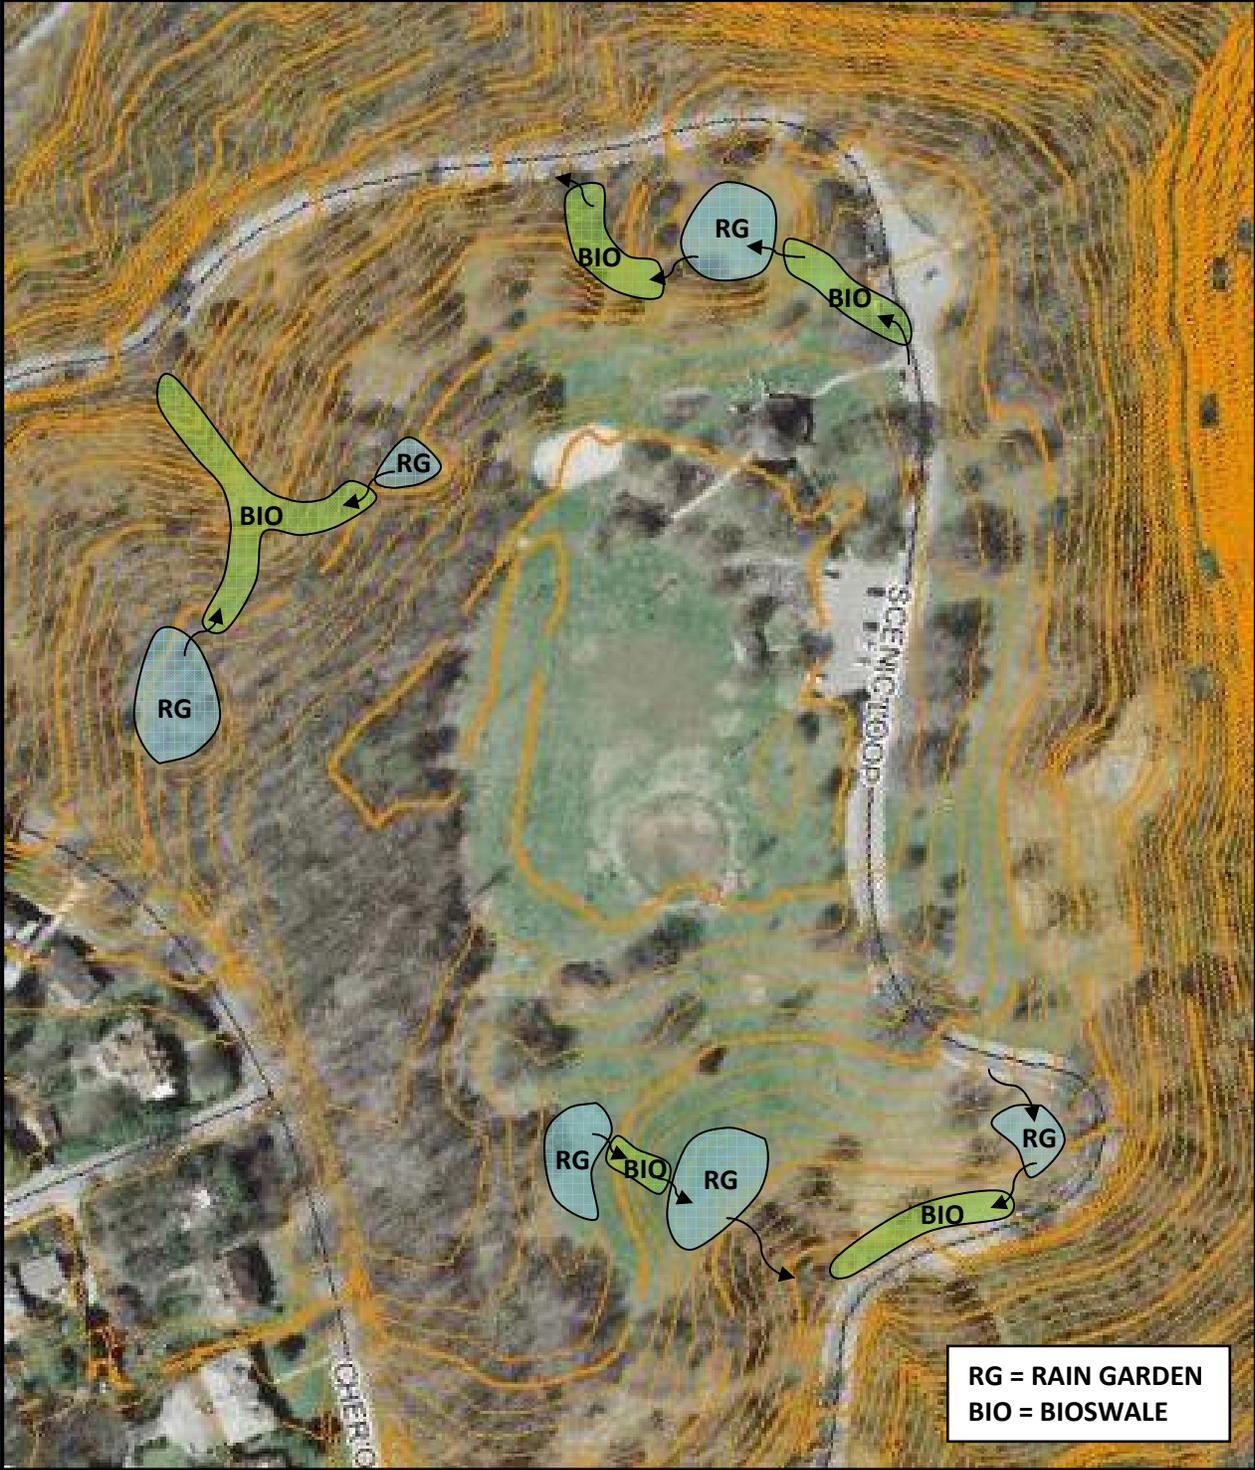
Figure 3. Suggested Locations for Rain Gardens and Bioswales

Replacing the undersized culverts noted above would improve the capacity of the stormwater system. Other upgrades to the stormwater system, for capacity and for water quality improvements, may include a series of rain gardens and bioswales. Rain gardens and bioswales are stormwater best management practices (BMPs) that are intended to slow down runoff (particularly from paved surfaces) and provide opportunities to filter out contaminants, including sediment, metals, and hydrocarbons. The topography, drainage patterns, and existing features (including the sinkhole west of the picnic shelter) provide good opportunities to use these BMPs to capture runoff and improve water quality. Routing stormwater runoff from the parking lot and Scenic Loop through a rain garden located in the large sinkhole will also improve the erosion problems along the crushed stone roadside swale and in the sharp bend east of the parking lot. Figure 3 below provides some suggested locations for rain gardens and bioswales.

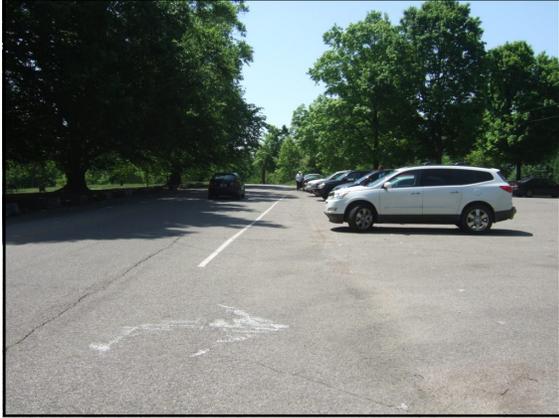
1. Paved drainage swale between Scenic Loop and the parking lot, looking south

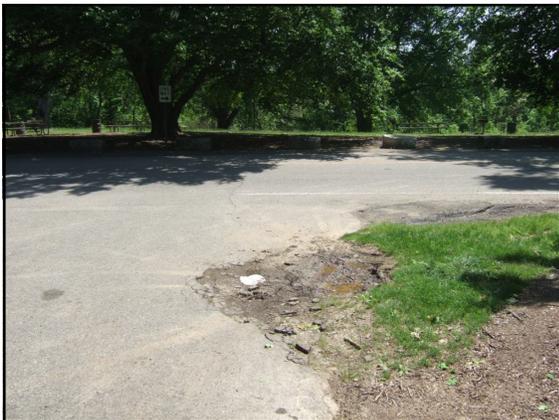
5. Poor drainage at southeast corner of parking lot

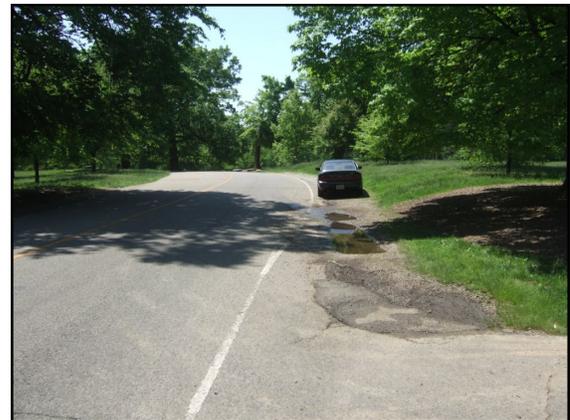
6. Standing water along edge of Scenic Loop just south of parking lot

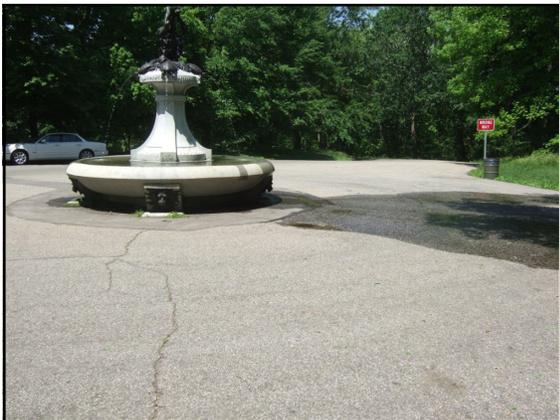
17. Transverse crack in asphalt pavement on the southeast side of the fountain

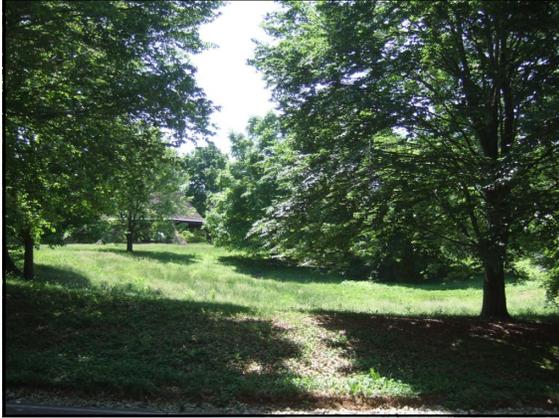
19. Large sinkhole, looking from Scenic Loop south toward tepee picnic shelter

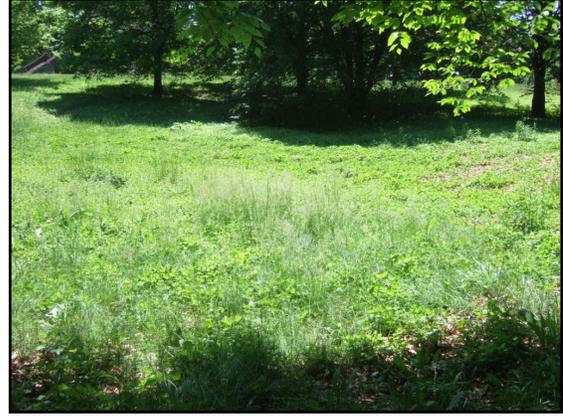
20. View of sinkhole bottom, looking south

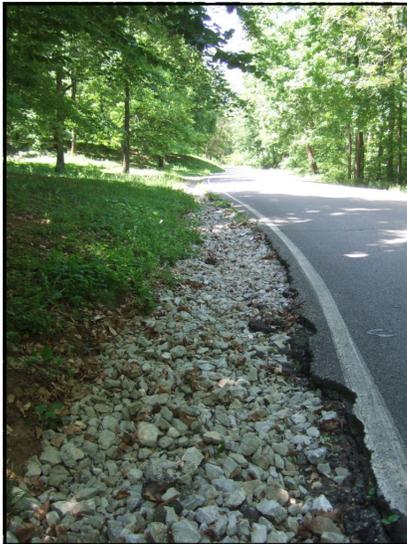
21. Crushed stone drainage swale along south side of Scenic Loop, pavement edge raveling

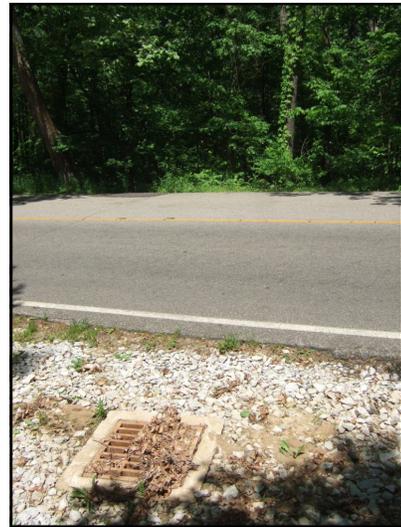
22. 24" x 24" catch basin on south side of Scenic Loop, near sinkhole

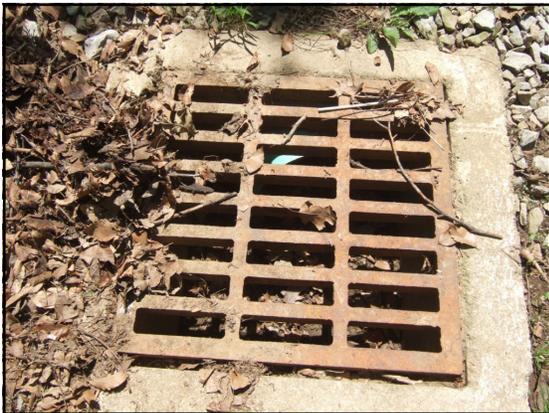
23. Leaves clogging 24"x24" catch basin

It is further recommended that the catch basin grates be regularly cleared of leaves and debris to improve the flow through the catch basins. Domed grates, rather than flat grates, can be used to reduce the amount of clogging in areas where leaves and debris often collect.

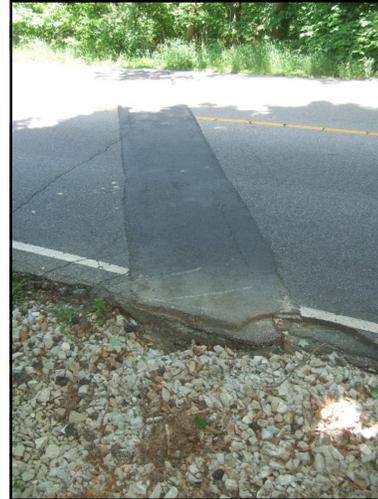
26. Asphalt patch at 12" PVC culvert, inlet covered with crushed stone

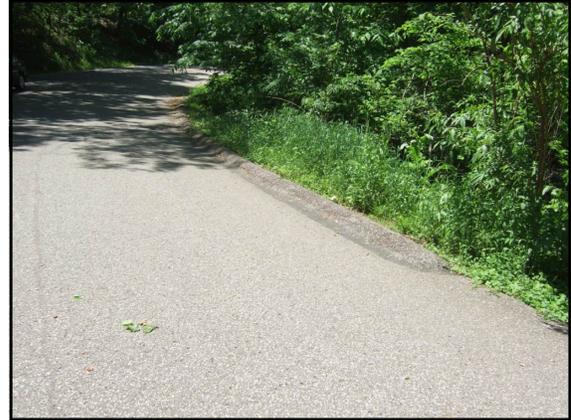
32. Asphalt curb along northeast side of Scenic Loop

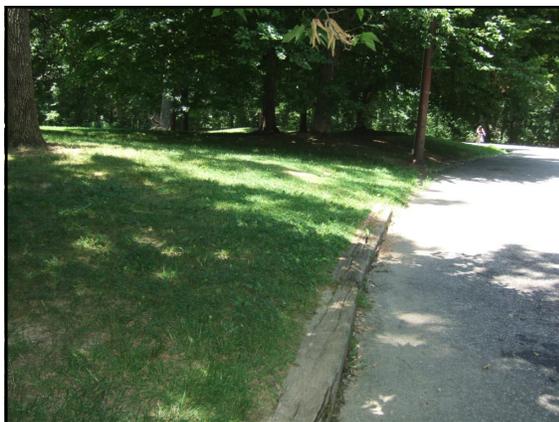
35. Railroad tie shoulder where parking lot drainage flows along west side of Scenic Loop

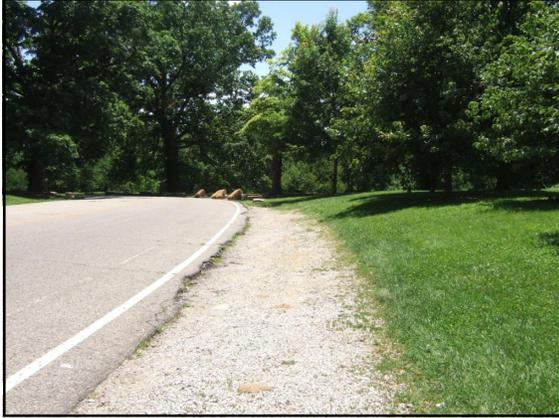
37. Gravel parking area along west side of Scenic Loop, raveling along asphalt shoulder

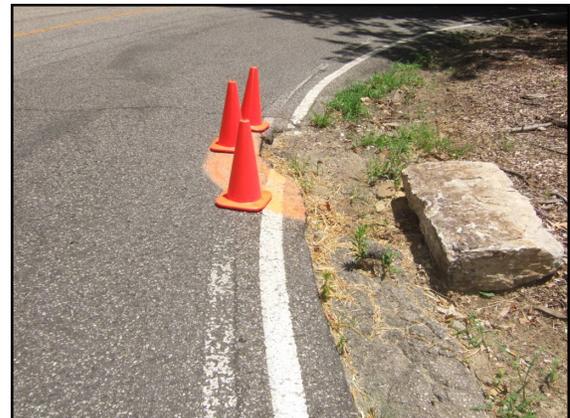
42. Broken pavement section at inside of curve on Scenic Loop

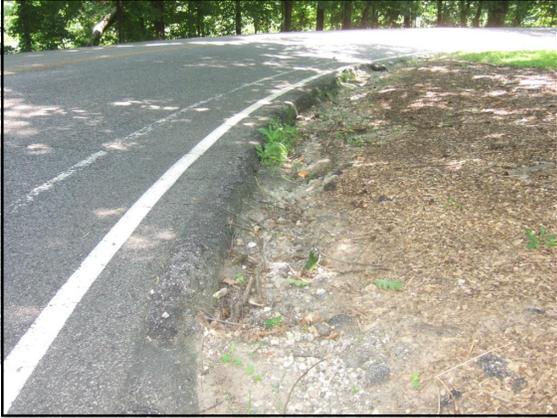
43. Roadside drainage and erosion at inside curve of Scenic Loop

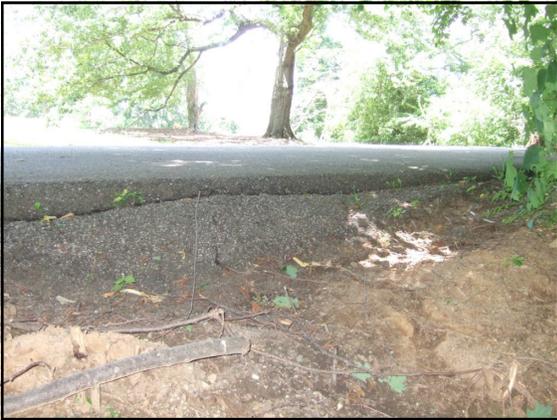
45. Steep drop-off and erosion where runoff from Scenic Loop flows off pavement

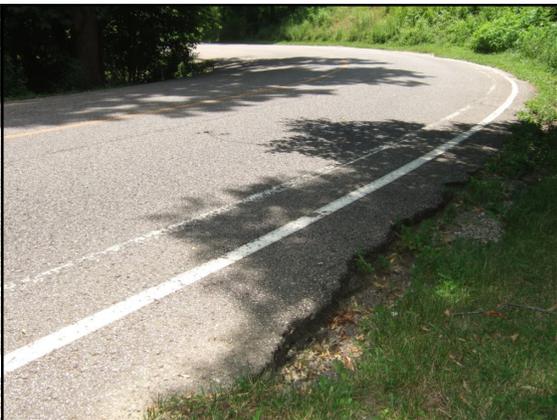
47. Asphalt pavement edge raveling at outside curve of Scenic Loop

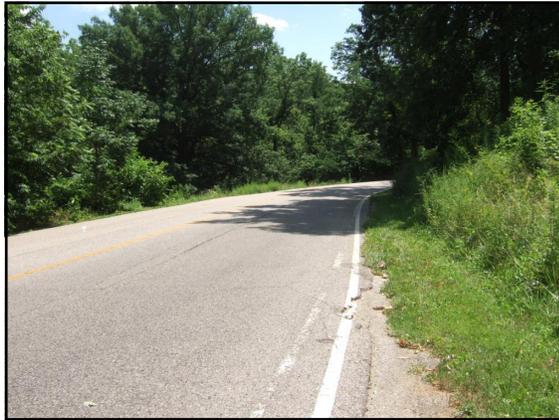
51. Little raveling along edge of asphalt pavement, grass shoulder along Scenic Loop

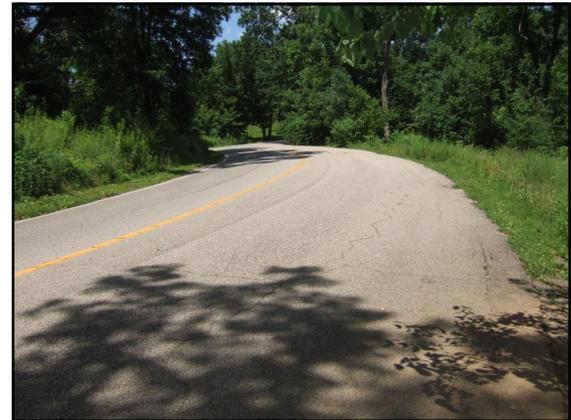
52. Longitudinal and transverse crack in asphalt pavement of Scenic Loop

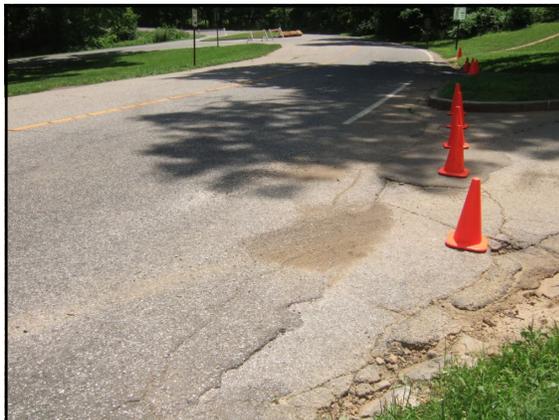
53. Poor drainage and broken pavement section at intersection of Scenic Loop and Bonnycastle Rd.
