Masonry

For Building Exteriors of Masonry: Brick, Stone, Terra Cotta, Concrete, Stucco and Mortar

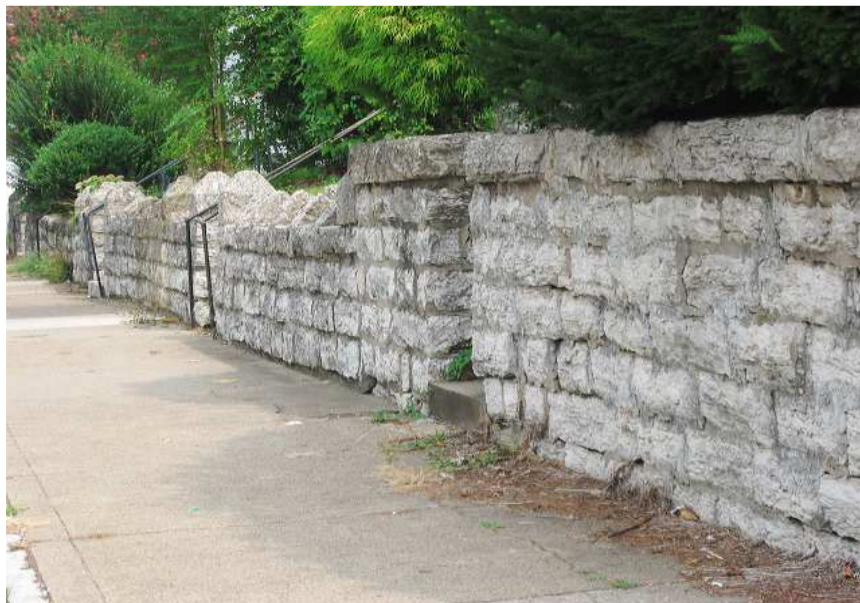
Limestone wall along Pope St.

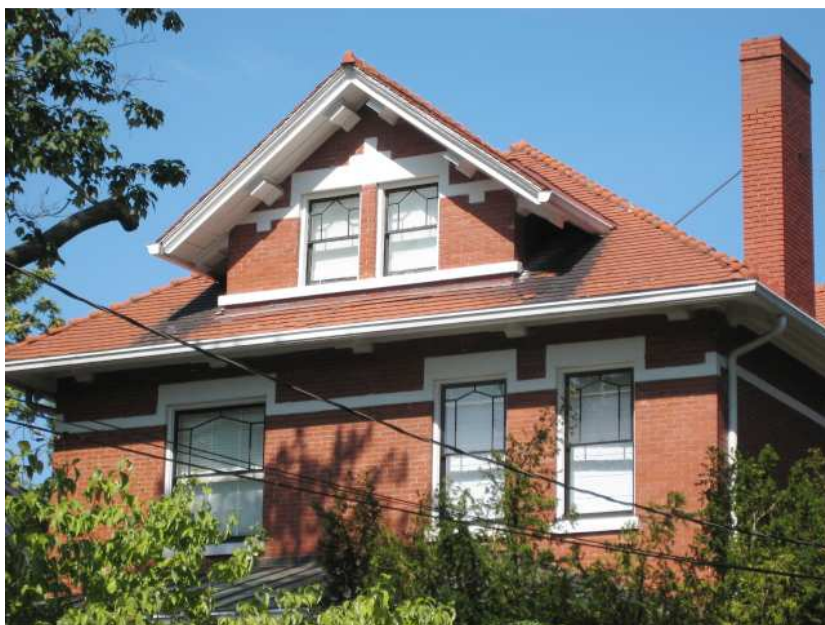
Terra cotta roof, brick walls, ornamental concrete trim on Vernon Ave.

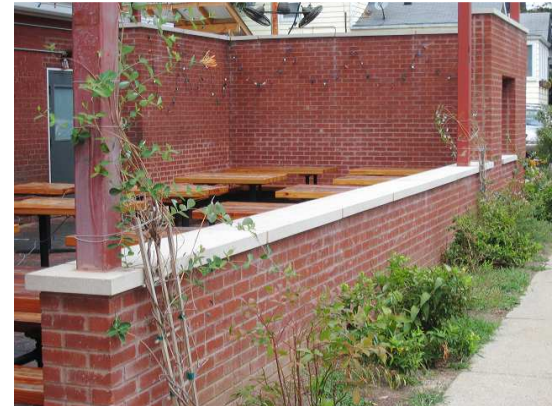
Masonry addition behind the historic Pope St. firehouse is both contemporary in design and compatible with its surroundings

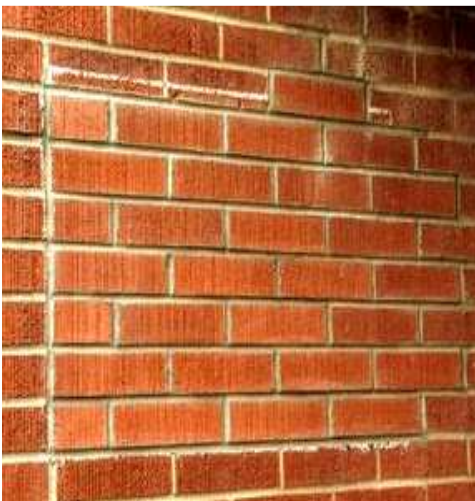
Where bricks are not "toothed-in," or the new bricks differ in size or color, patches are obvious. Above, the patch bricks are toothed in appropriately on the right, but not on the left; also, the color doesn't match.

M5 The existing bonding pattern, coursing, color, size, and strength of masonry should be matched when repairing a section of brick wall. Bricks should be toothed-in to historic brickwork to strengthen the joint between new and old, except where new construction (e.g., a room addition) meets old construction.

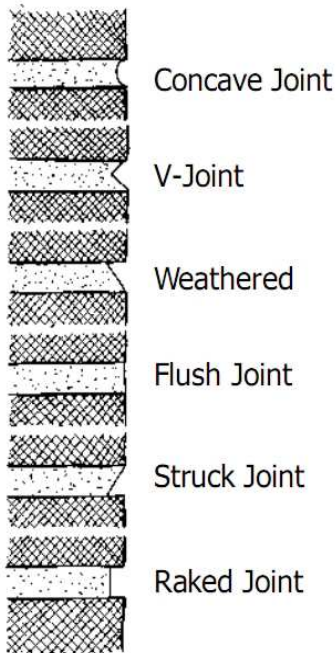
TYPES OF MORTAR JOINTS

The type of mortar joint selected can affect the visual appearance of a masonry wall and the way the wall sheds water.

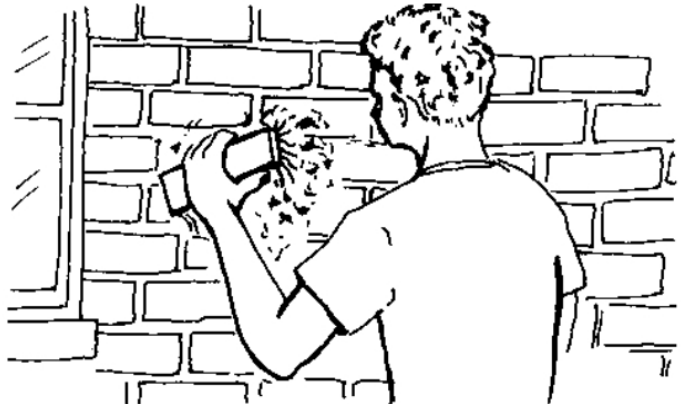
Scrubbing with natural-bristle brushes is recommended.

- Do not clean masonry surfaces unless heavy soiling is causing deterioration. Cleaning should use only the gentlest means necessary, such as low-pressure water and natural bristle brushes. Do not use metal brushes, which can damage masonry surfaces.

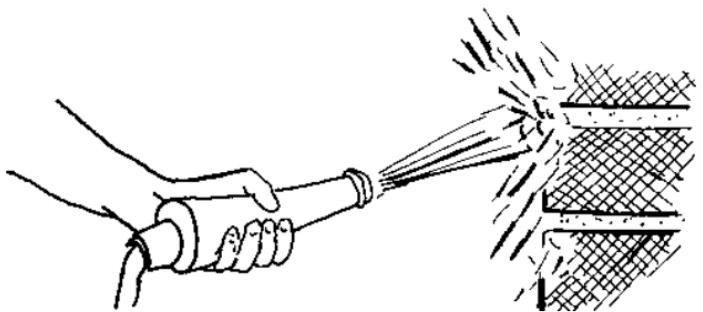
High-pressure water or sandblasting erodes the surface of the brick and dislodges mortar and should be avoided.

- M19** Sandblasting or high-pressure water treatments should not be used to clean historic masonry. Both sandblasting and high-pressure water (greater than 300 psi) remove the tough, outer-protective surface of the brick and loosen mortar joints, accelerating deterioration.

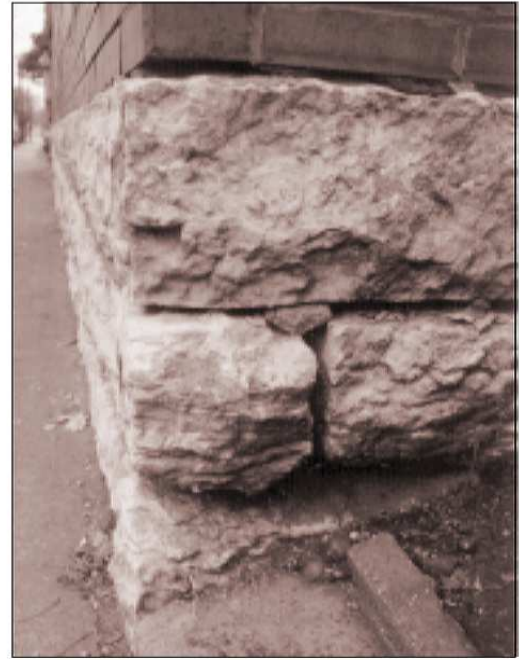
Moisture often enter walls from the base. Repeated freezing and thawing have crumbled the mortar at the foundation level of this structure.

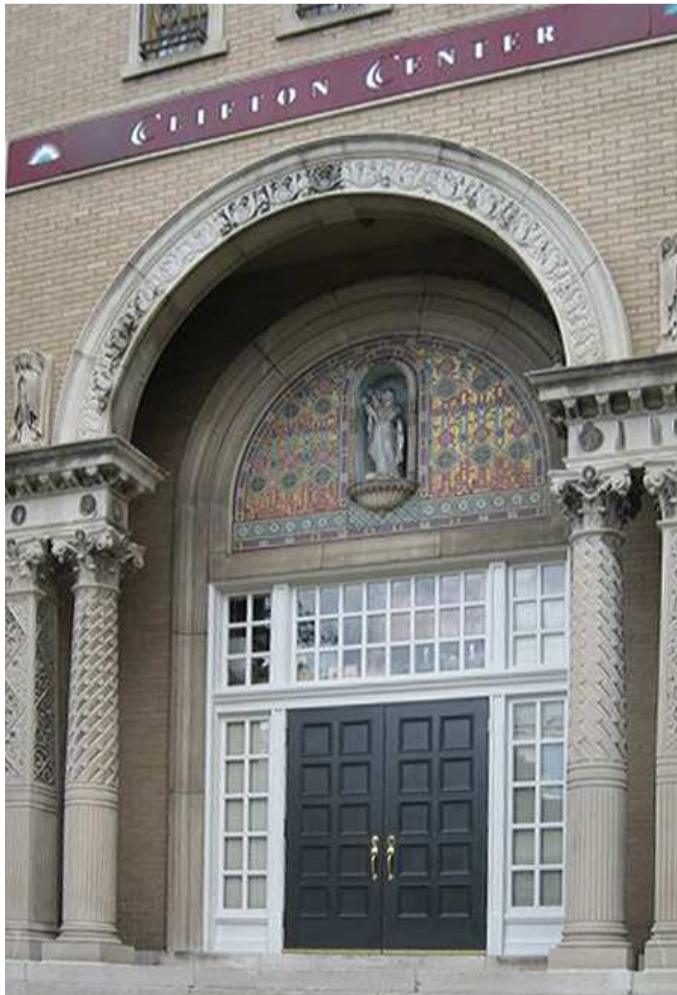
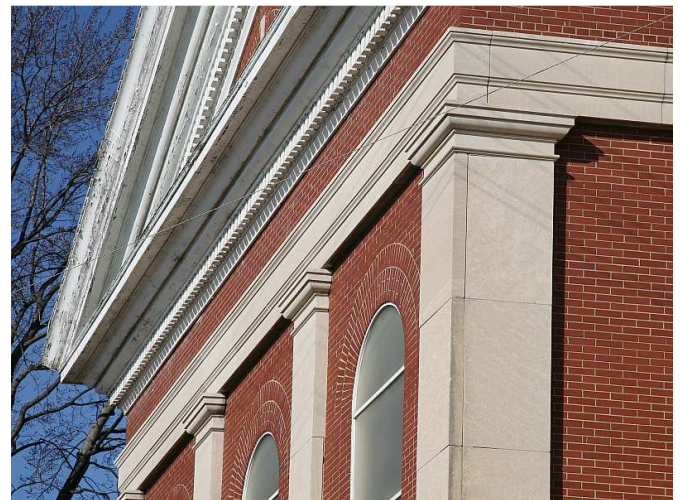
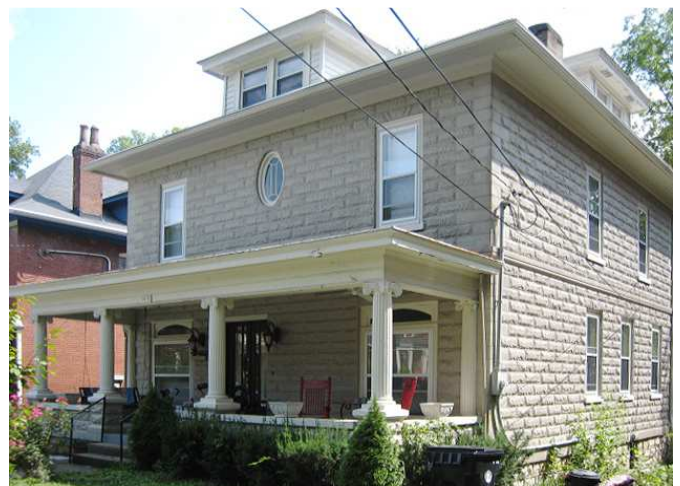
A Glimpse of Clifton's Historic Masonry Variety

Left: Cut limestone, brick and tile adorn the Clifton Center's Payne St. entrance. **Top right:** Cut limestone detailing on Clifton Baptist Church. **Bottom right:** American four-square on Coral Ave. exemplifies rock-faced (aka "rusticated") concrete block.

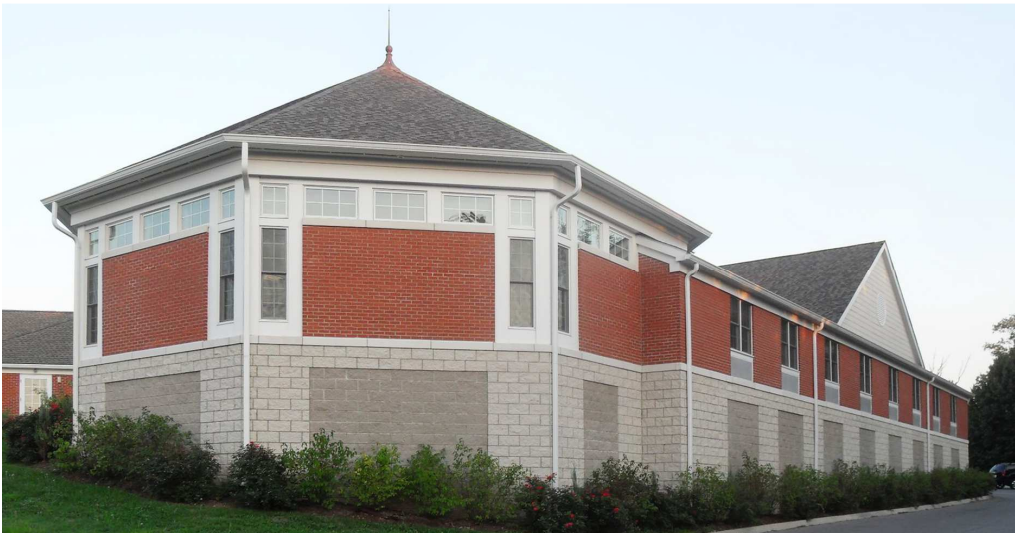
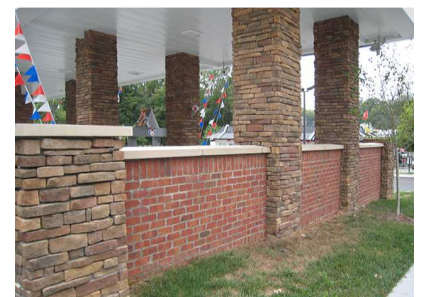
*Clifton's new construction harmonizes with its historic masonry context. **Left:** Payne St. residential facility's foundation adds visual interest to rock-faced block appearance. **Below:** Gas station masonry reflects Clifton's quarries, including the cliff just behind the station.*
