# Chapter 8

## The Built Landscape

Prepared by Landscapes, Westport CT

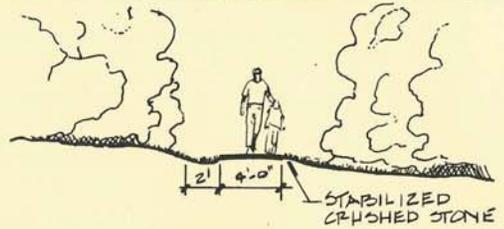
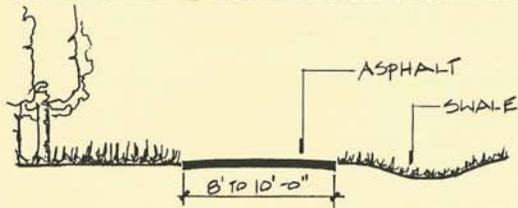
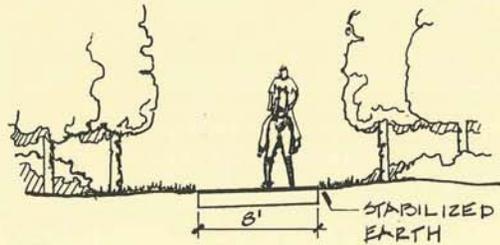
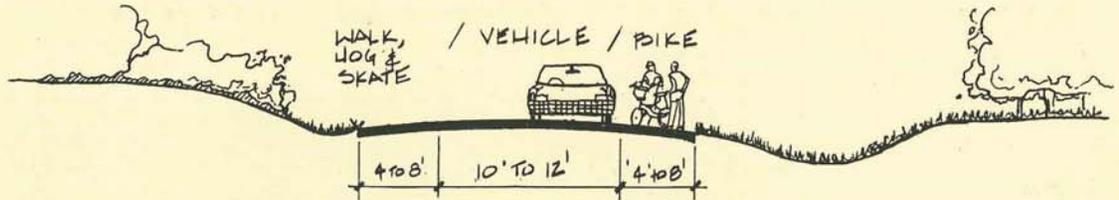
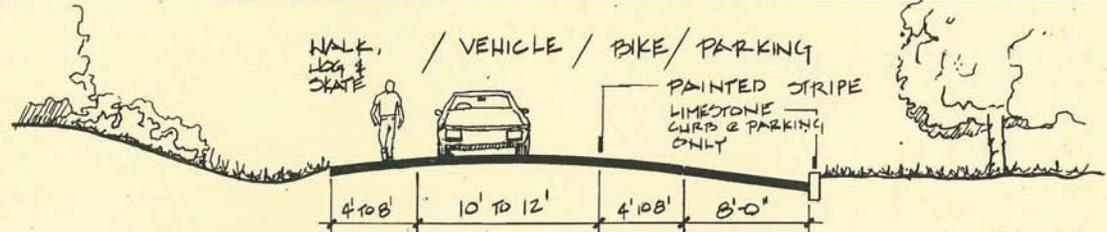
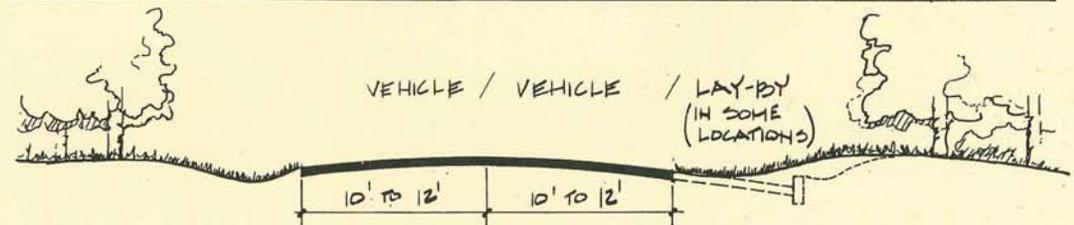
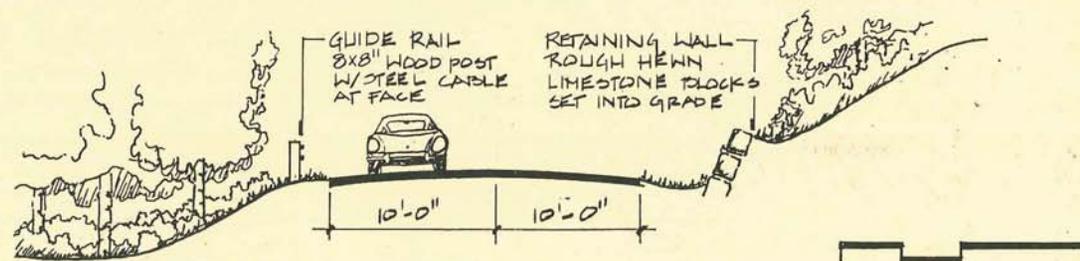
MOWN PATH THROUGH MEADOW

WOODLAND TRAIL (STABILIZED)

PARK (10') & PARKWAY (8') MULTI-USE

BRIDLE PATH

CIRCULATION SYSTEMS

MULTI-USE DRIVE / UNIVERSAL ACCESS W/ STRIPED LANES

MULTI-USE DRIVE / UNIVERSAL ACCESS (ONE WAY) W/ LAY-BY PARKING

TWO WAY DRIVE W/ WIDE CROSS SECTION IN OPEN AREAS

TWO WAY DRIVE ON STEEP GROUND

1. Circulation system cross sections. (Landscapes, 1994)

The multi-use path cross section is designed to accommodate some maintenance vehicle access without degradation and is as thick as the standard drive and parking pavements. This path is constructed on a

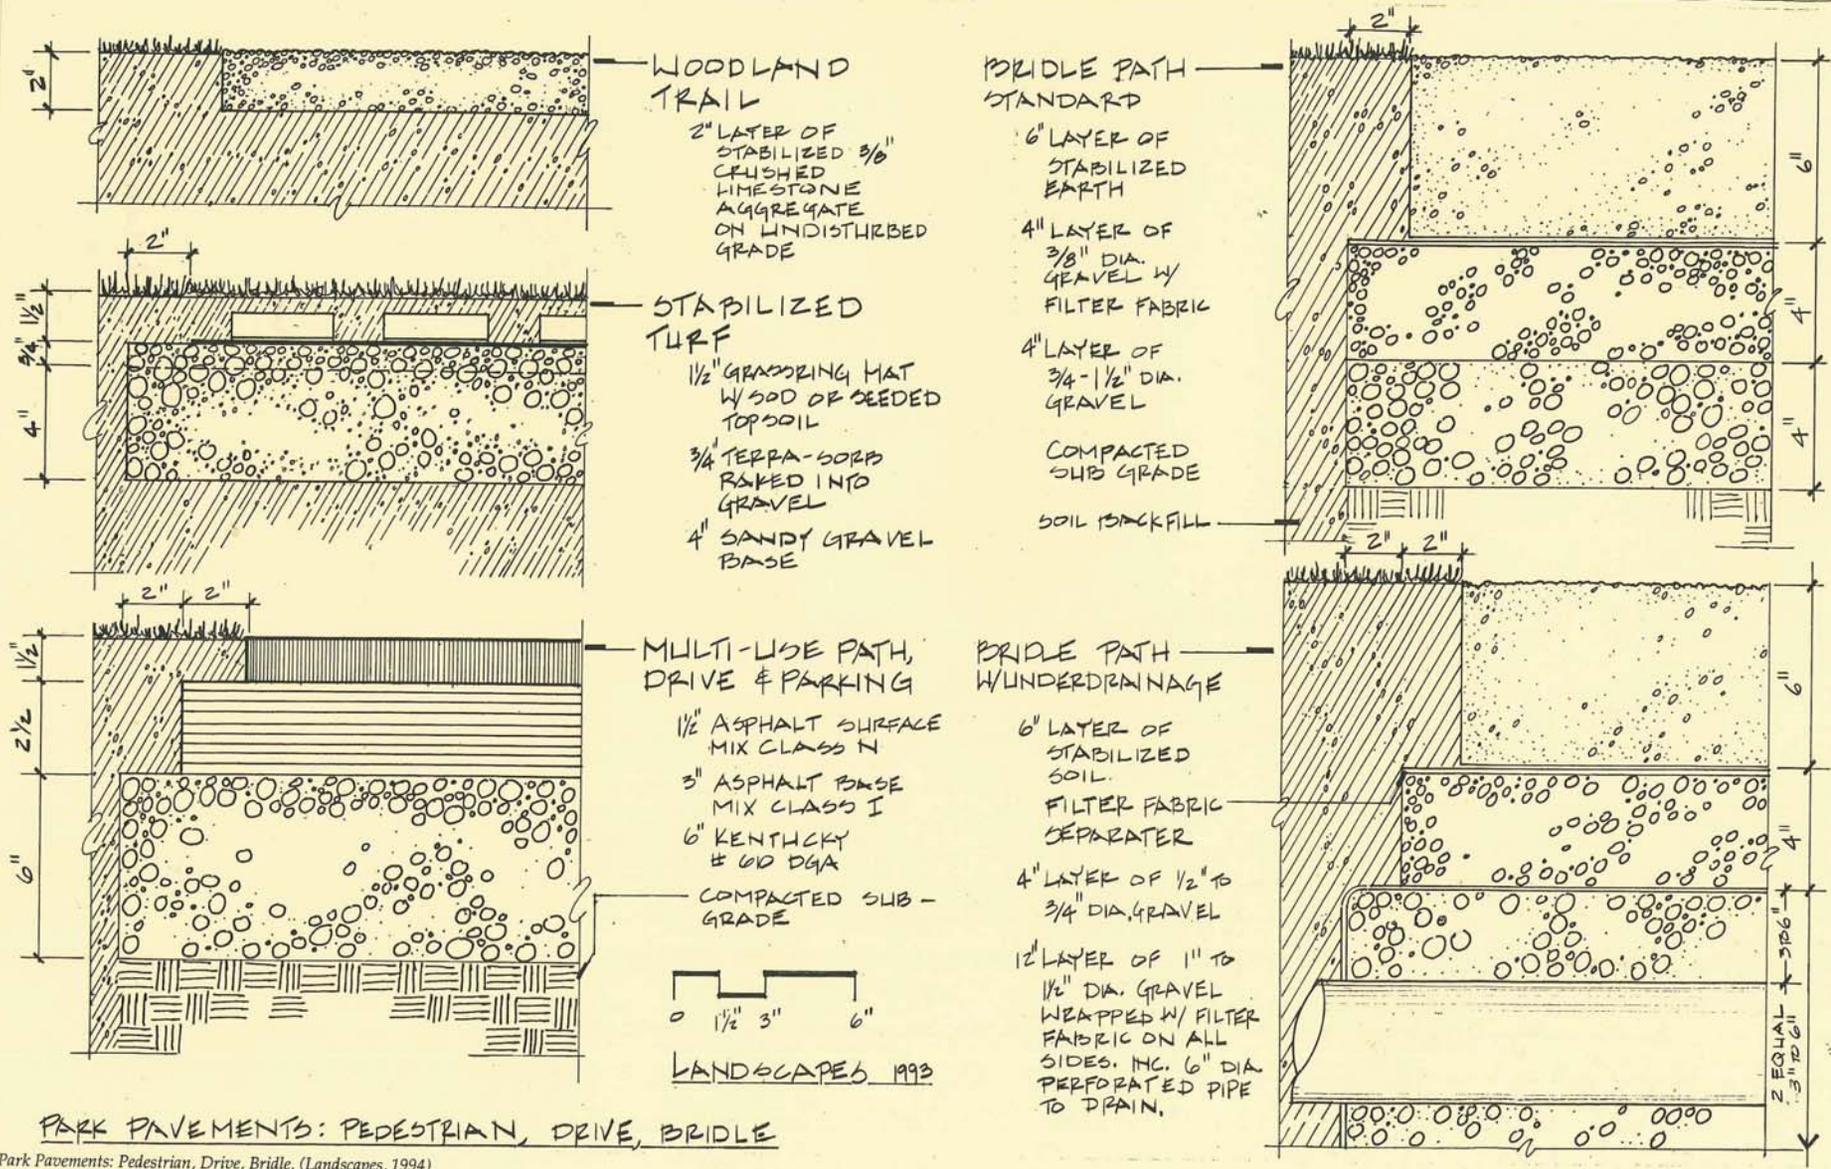
PARK PAVEMENTS: PEDESTRIAN, DRIVE, BRIDLE

2. Park Pavements: Pedestrian, Drive, Bridle. (Landscapes, 1994)

The drive and parking lot pavements are full depth asphalt for good durability. Six inches of compacted gravel, Kentucky #610 DGA, are placed over a compacted subgrade. A 3-inch asphalt base course is installed over this base and is followed by a 1-1/2 inch top course, of mix class N, which has the limestone aggregate to eventually weather to grey as described above. At the edges of this pavement the subgrade layers extend slightly beyond the surface pavement to provide good

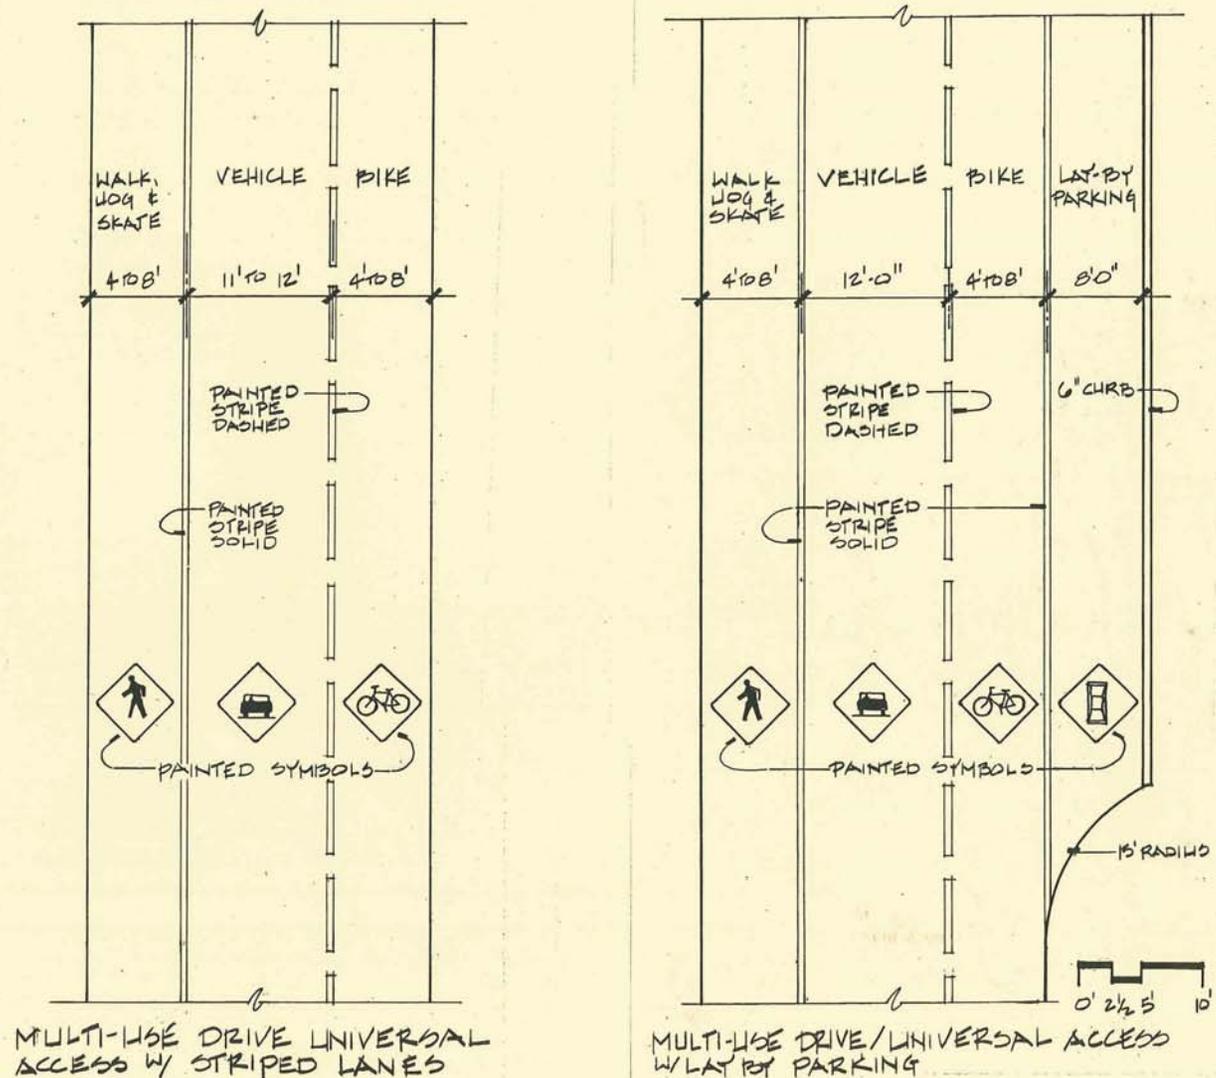
3. Multi-Use Drive with striped lanes and lay-by parking. (Landscapes, 1994)

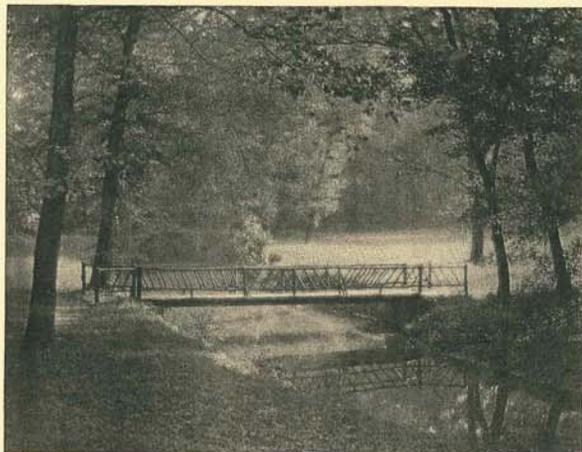
4. (Top) Historic footbridge over Beargrass Creek, Cherokee Park, in the rustic style, c. 1929. (University of Louisville, Photographic Archives, Caufield & Shook Collection)

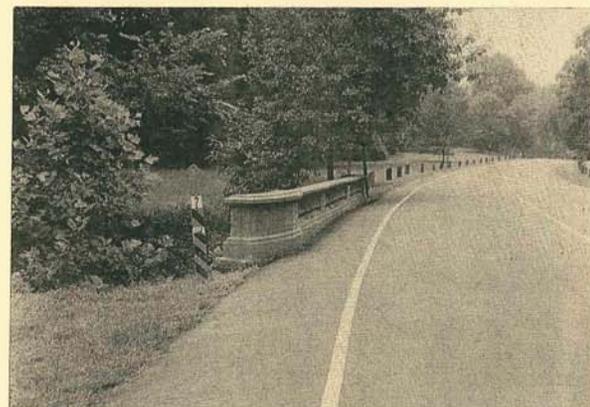
5. (Bottom) Contemporary view in Cherokee Park of bridge railing and asphalt park drive. The drive has been continually raised against the bridge. (Landscapes, 1993)

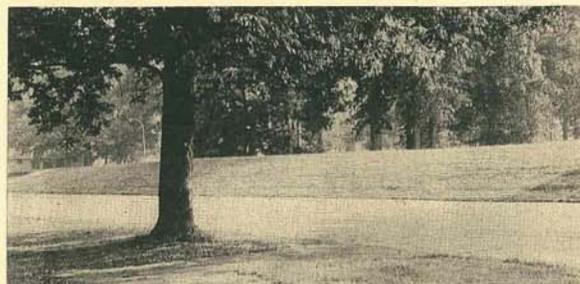
6. (Top) Intersection of pedestrian path and park drive in Shawnee Park showing a portion of these dual systems still extant although many linking segments are lost. (Landscapes, 1993)

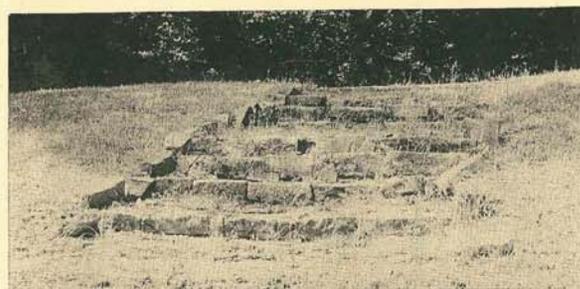
7. (Middle) Stone steps in Iroquois Park in disrepair. (Landscapes, 1993)

In a few steep areas, paths connect with stone steps which should be repaired or reset to match their historic detailing. In Iroquois Park and Cherokee Park, pedestrian bridges should be constructed over ravines and creeks with the same visual qualities as the historic bridge view shown in [4]. The materials for these bridges would be wooden timbers and peeled bark logs. Many rustic bridges have been built in recent years in Central Park, New York City and these could be studied. The construction of these bridges should consider high stormwater flows through Beargrass Creek.

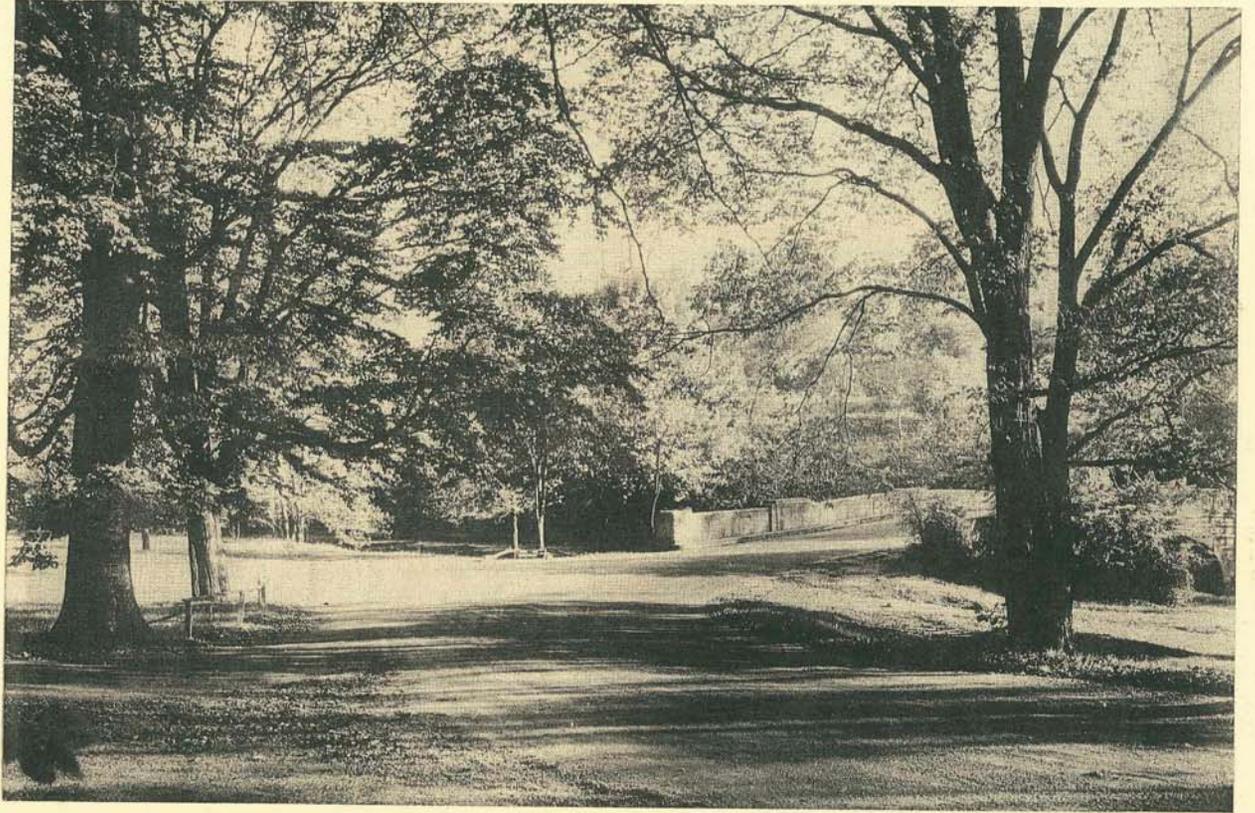
9. View in Cherokee Park of gently graded drive and pedestrian walks near Belknap Bridge, showing the integrated circulation system that is partially lost today, c. 1932. (University of Louisville, Photographic Archives, Caufield & Shook Collection)

The circulation systems of the parks and parkways are the access routes to move through and enjoy the landscape. Originally the drives and paths were constructed of coursed gravel, going from larger to smaller stones, often with a fine crushed stone or cinder surface. This construction is porous, allowing for some percolation of water. These path and drive materials required at least annual care with raking or topdressing and rolling and a certain amount of these somewhat mobile materials would wash away with runoff. The circulation system of the parks and parkways was meant to be graded effectively into the setting for both proper function and harmony with the surrounding landscape. Conforming to existing grades to the greatest extent possible, drives and paths were balanced for cut and fill, were shaped along contours and were sited to blend into the landscapes. For example they would not cut through open meadows, but rather would align along the edges, providing a changing sequence of views across the space without compromising it. See [8] and [9] for historic views of drives. The grading approach to the circulation system is discussed in the historic landscape analyses of the parks and parkways. In each of the historic landscapes provided access along steeper portions of pedestrian paths and in Cherokee Park rustic timber bridges linked pedestrian paths across Beargrass Creek.

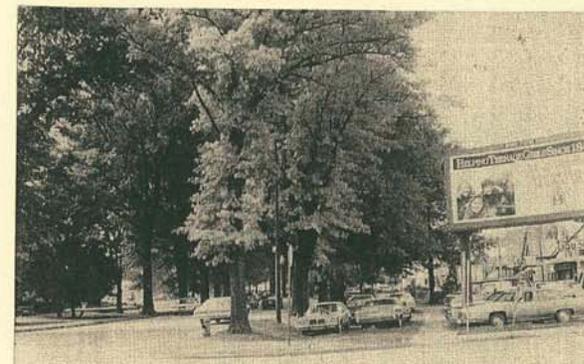
13. (Top) Contemporary view of Algonquin Parkway showing surface parking that is degrading the parkway greenspace. (Landscapes, 1993)

Along the parkways parking is also an issue. Degradation of parkway greenspace is often caused by surface parking between the tree rows, especially along the Western Parkways as seen in [13] at the beginning of Algonquin Parkway. In general, private vehicle parking on the parkway main drives is prohibited. Parallel parking on the Southern Parkway service drives is allowed on one side where pavement widths can accommodate this use.

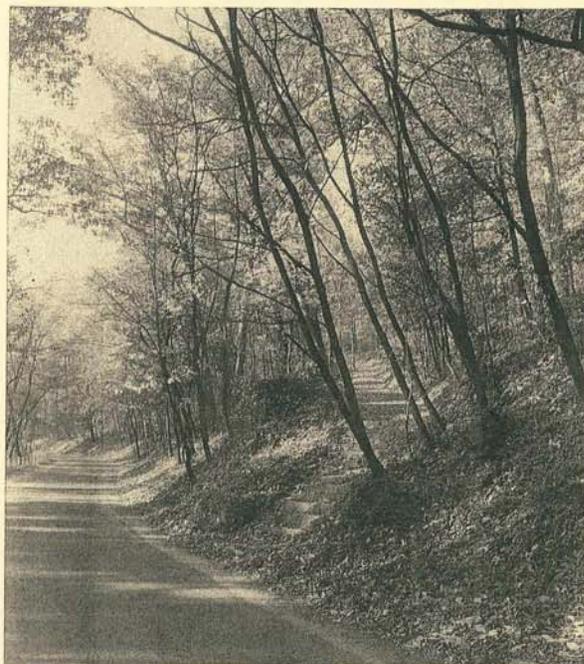
14. (Bottom) Small retaining wall and sandstone stairs leading up hill from drive edge in Iroquois Park, c. early 20th century. (University of Louisville, Photographic Archives)

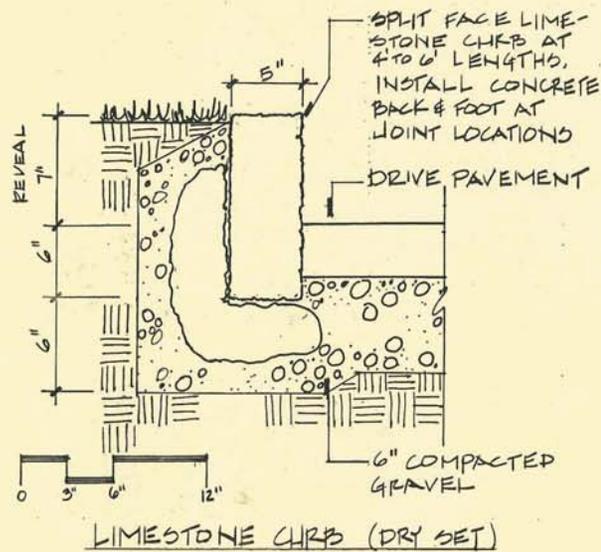
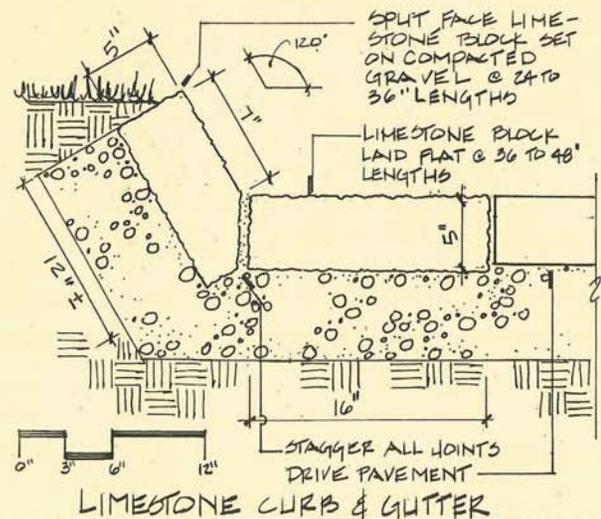
15. Dry-set limestone curb and limestone curb and gutter details. (Landscapes, 1993)

On the parkways, main drive curbs are recommended. The preferred alternative is the dry-set limestone curb with concrete placed at joints [15]. This detailing limits existing tree root damage because the 5 inches of stone below grade is a shallower depth than other curb cross sections. Another, more intensive approach is the section shown as "Limestone Curb, Concrete Set with Dowels" [16]. This cross-section is a more durable and considerably more expensive approach that requires an 18-inch depth below grade, and would create considerably more tree root damage. The doweled detailing is stronger and should be considered for use on parkway corners and other areas that may receive more impact. A limestone curb with a vertical face should be

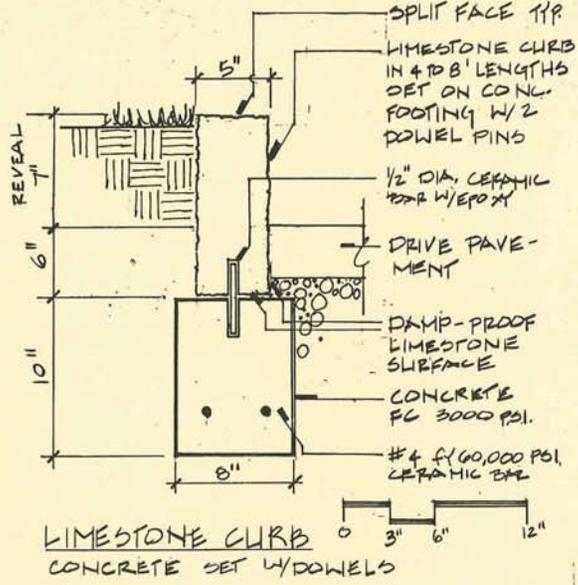
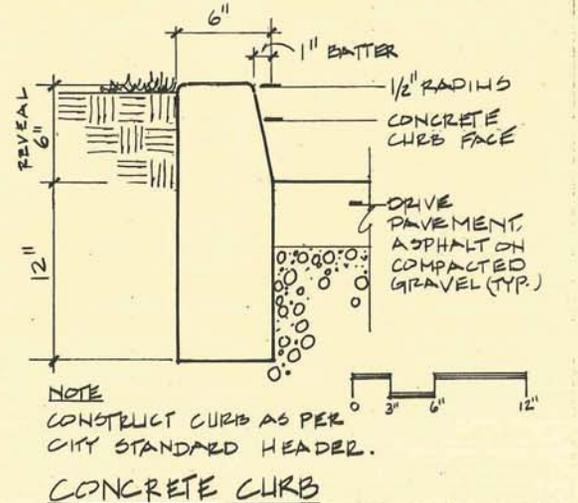
16. Limestone curb on concrete set with dowels, and city standard concrete curb details (Landscapes, 1993)

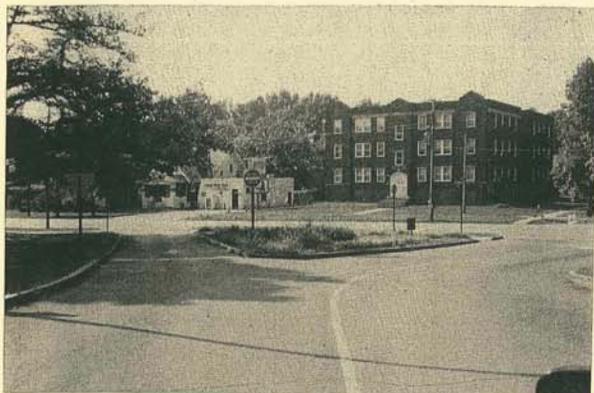
17. (Top) Granite curbing along drive edges and island at entrance to Shawnee Park from Southwestern Parkway. (Landscapes, 1993)

Most park-drive edges are uncurbed with minor exceptions such as the granite curbing around the island and adjacent drives at the entrance to Shawnee Park from Southwestern Parkway [17]. An integrated concrete curb and gutter detail was installed along Eastern Parkway in the 1940s. The cross section of this edge is quite curved and the drive surface is extremely crowned, causing some difficulty in access along driveways for adjacent landowners [18]. Some owners have filled the curved gutter blocking drainage and others bridged the gap with steel plates or paved with a drainage pipe below. A similar concrete gutter is seen along portions of Southwestern Parkway and also creates access problems which owners adapt to as shown in [19]. Vertical concrete curbs have been recently added along the main drive of Southern

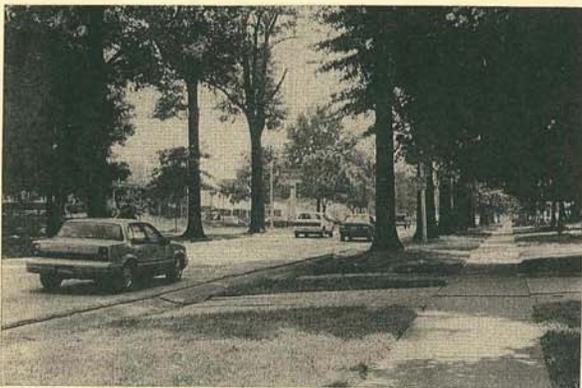
18. (Bottom) Integrated concrete curb and gutter along Eastern Parkway. (Landscapes, 1993)

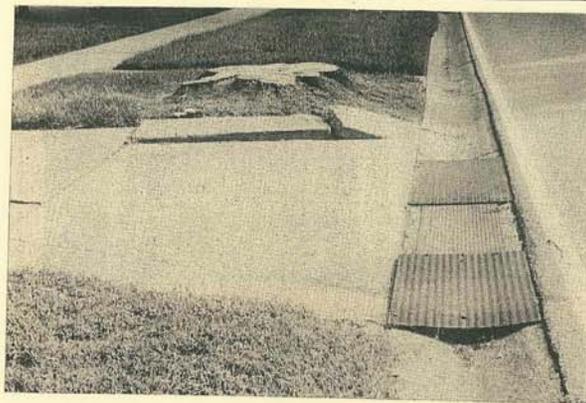
19. (Top) Concrete gutter along Southwestern Parkway, note metal plates for driveway crossing and recently removed large tree with stump remaining. Tree stump shows about 90 annual rings. (Landscapes, 1993)

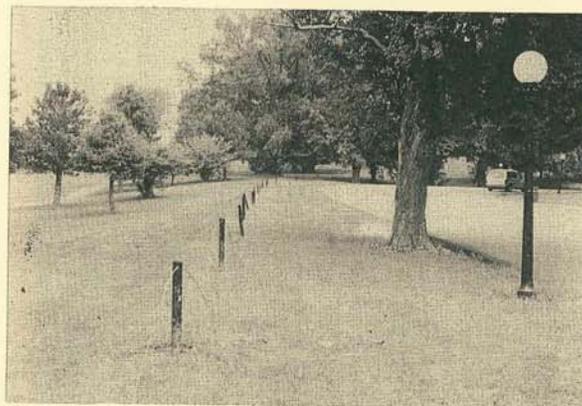
20. (Bottom) Broken post and wire barrier along Cherokee Golf Course. (Landscapes, 1993)

In some areas, drive edges have barriers of metal poles set about 15 feet apart with wire running through, as shown in [20] along the Cherokee Golf Course frontage. This system of poles and wire is about 20 feet off the drive and the single wire is broken making the barrier ineffective. Another system used along Willow Park [21] is a row of 8-inch square cedar posts set in concrete on about 7 foot centers. At some locations along park drives, other wooden posts are used. At Iroquois Park, there may be remnants of the post and wire system shown in historic views. Areas along Uppill Road in Iroquois Park and curves in Cherokee Park have a metal flex guardrail at drive edges.

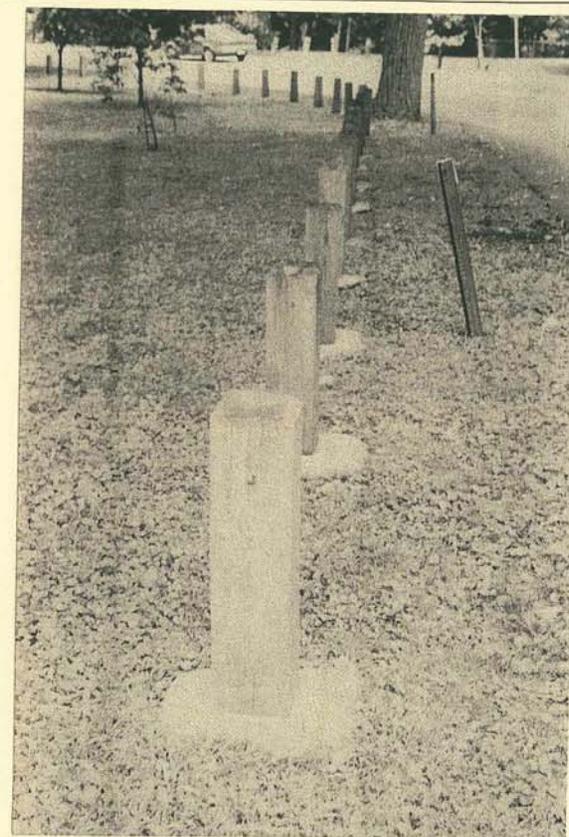
21. Closely spaced wooden bollards set in concrete at Willow Park. (Landscapes, 1993)

used along Eastern and Western Parkways. The newly installed concrete curb along Southern Parkway should be retained and the few remaining sections should match this recent construction rather than move into an additional material. Cherokee Parkway should retain its angled limestone curb and gutter. The existing curb should be repaired as needed with individual blocks reset or replaced. This limestone block curb should also be constructed around Willow Park and the wooden bollards along the edge should be removed afterward.

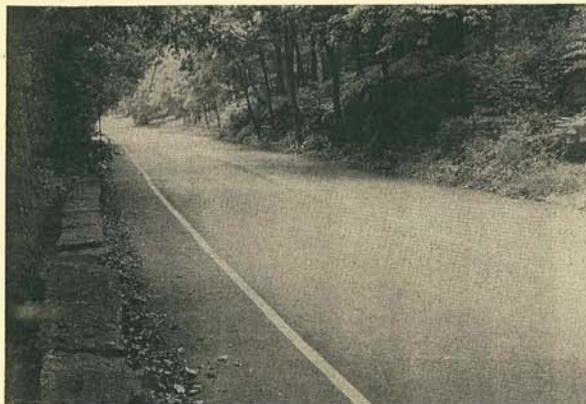
22. (Top) Limestone block retaining wall at drive edge in Cherokee Park. (Landscapes, 1993)

Stone retaining walls in Cherokee Park are an important character-defining element of the drives. Some of these have obvious problems today. They should be retained, stabilized and repaired as needed. If other steep areas of the drive require edge treatment these limestone block retaining walls should be used as the model. At Iroquois Park the stone retaining wall segments that remain are in some disrepair but historic views, such as the low one shown beside the steps in [14], have a rustic, irregular quality that should be replicated whenever retaining walls are required. Likewise, the walls at vistas should be more rustic in quality, with large stones used to form an irregular top course. For example, the wall at Krupps Point has been dismantled and if rebuilt should match historic views.

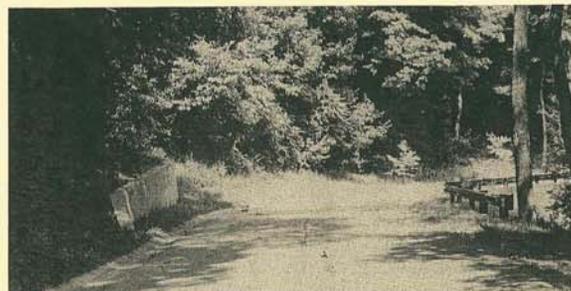
23. (Bottom) Curving limestone block retaining wall along the drive paralleling Beargrass Creek, Cherokee Park. (Andropogon Associates, 1993)

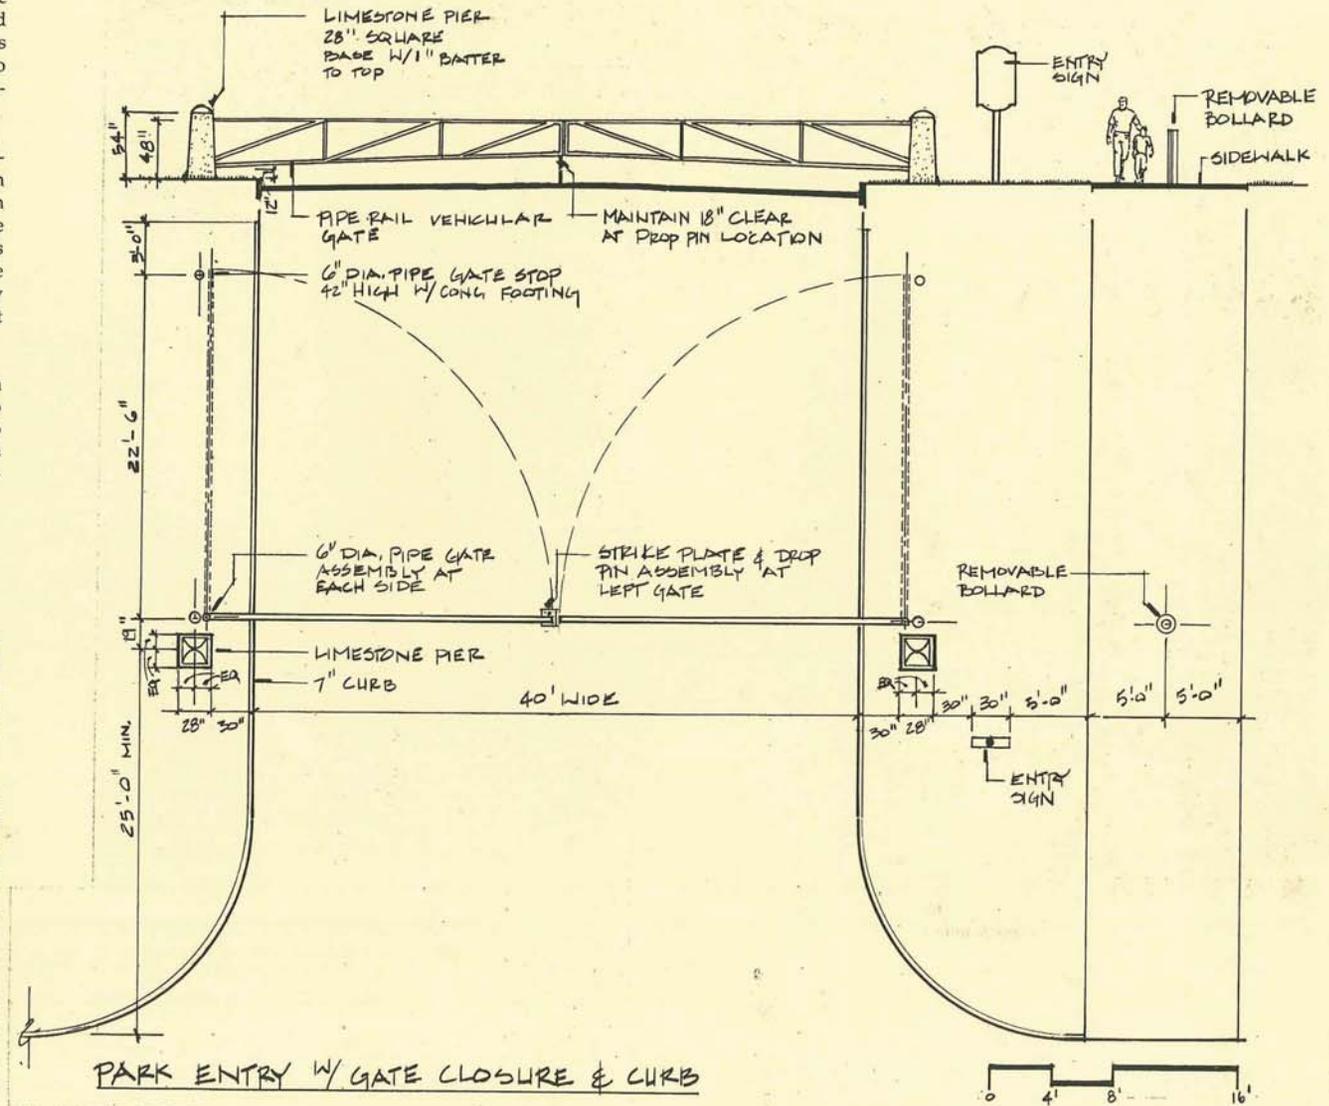
28. Park Entry with gate closure and curb. (Landscapes, 1993)

The recommended gate-closing design is at two scales to accommodate a narrow park drive [29] or a main park entry [28]. Both gates show a pair of square limestone piers with rounded dome caps. These piers are set back 25 feet from the park entry to allow one vehicle to pull in and open the gate. A detail of one pier for the larger gate is shown in [30]. This detail shows the plan and elevation of this 28-inch square pier with a 1-inch batter on all sides and a dome-shaped top. A concrete foundation would secure both the dowel pinned stone pier and the steel gate post.

A sturdy, tubular metal gate is hung on poles behind the piers. When the gates are open, they extend behind the piers and are less obtrusive in the park landscape, at least from the view along the park drive. The standard park drive gate swings to one side, while the wider park entry gate swings to both sides and joins in the middle with a strike plate and a drop pin assembly. Limestone curbs are shown at both gate locations for a distance of about 50 feet at the entry and possibly less within the park at narrow drive closings.

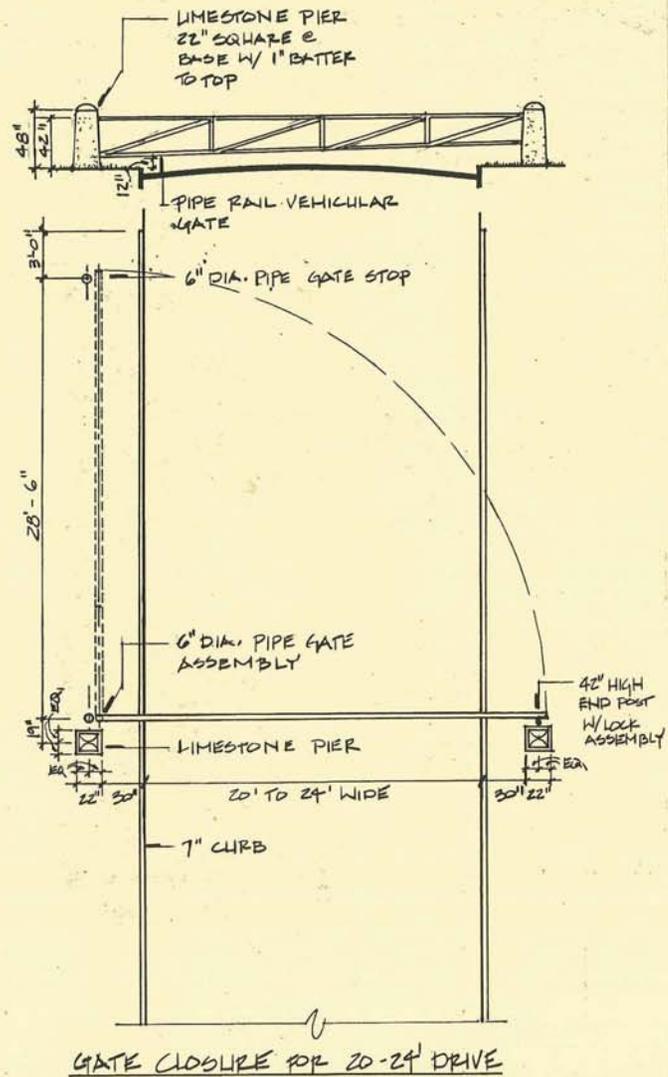
29. Gate closure for 20'-24' drives. (Landscapes, 1993)

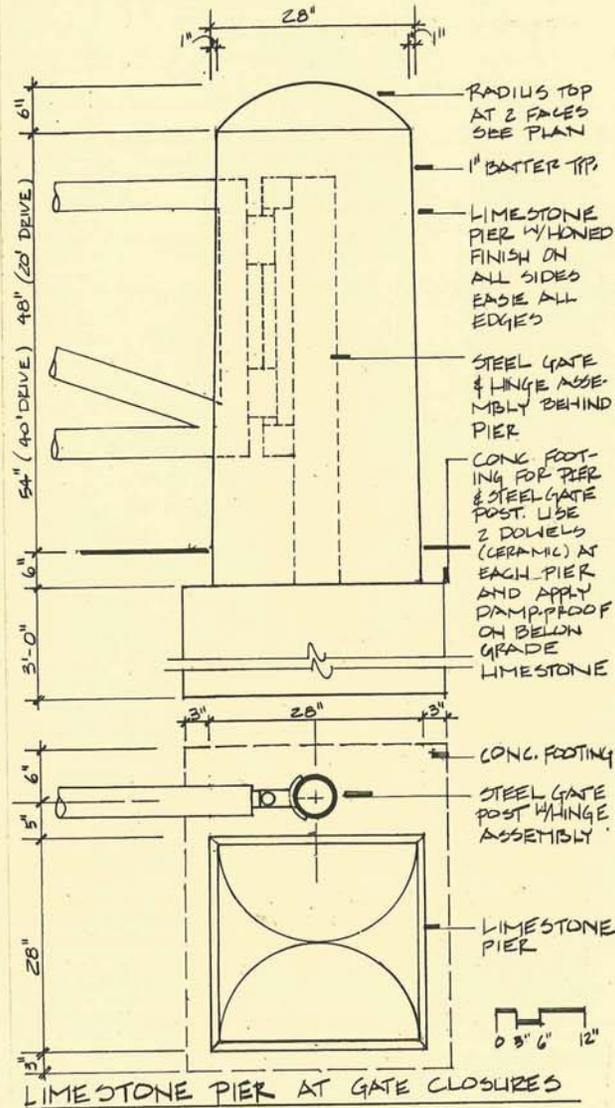
30. Limestone pier at gate closure. (Landscapes, 1993)

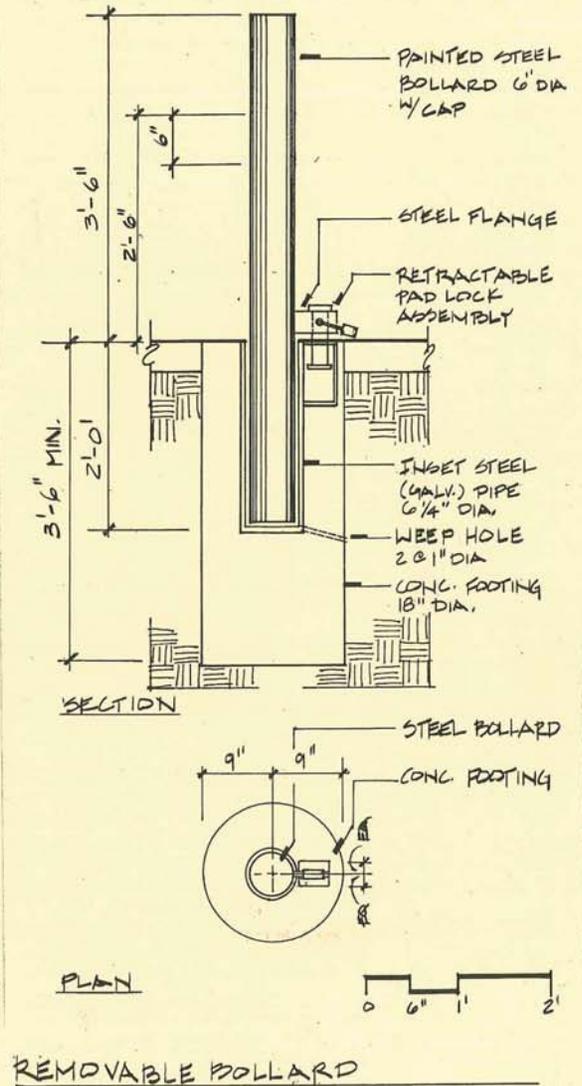
31. Removable bollard. (Landscapes, 1993)

Where a 10-foot pedestrian path, with a drop curb for universal access, parallels the park entry a removable bollard [31] is installed in the center of the path. The bollard is made of a 6-inch diameter, capped steel tube that is 5 foot, 6 inches high. It is shown with a retractable padlock that would be positioned at the back of the bollard. This removable bollard allows for service or emergency vehicle access to park paths while blocking private vehicle access. It can be used wherever this type of access is required. The main park entry sign is also placed in this entry composition. The sign drawings appear later in this chapter.

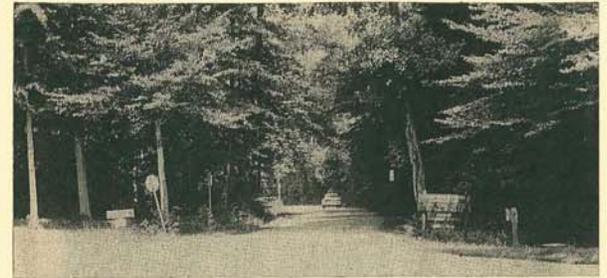
32. (Top) Ungated entrance to Iroquois Park with two small groups of wooden identification and regulatory signs. (Landscapes, 1993)

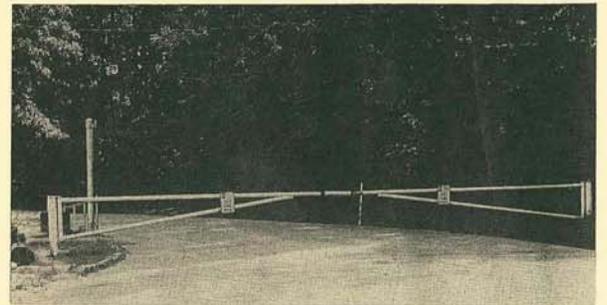
33. (Middle) Entrance to Uppill Road in Iroquois Park with metal tubular swinging gate. (Landscapes, 1993)

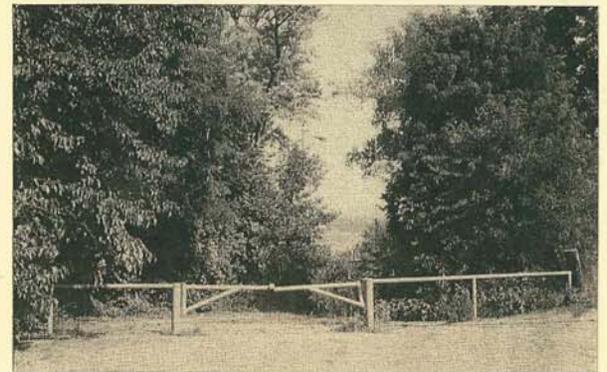
34. (Bottom) Combination of fixed and movable gates at Shawnee Park. (Landscapes, 1993)

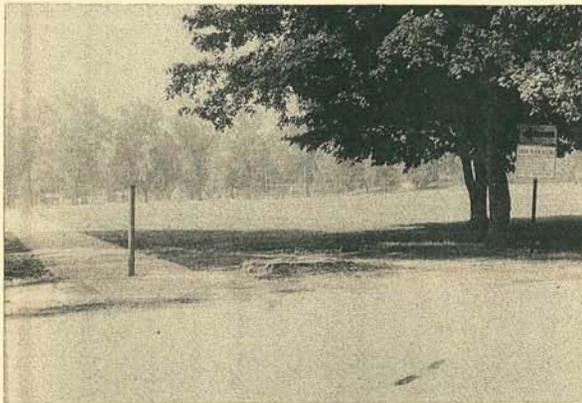
35. (Top) Fixed tubular metal bollard centered in pedestrian path at the north entrance to Shawnee Park. (Landscapes, 1993)

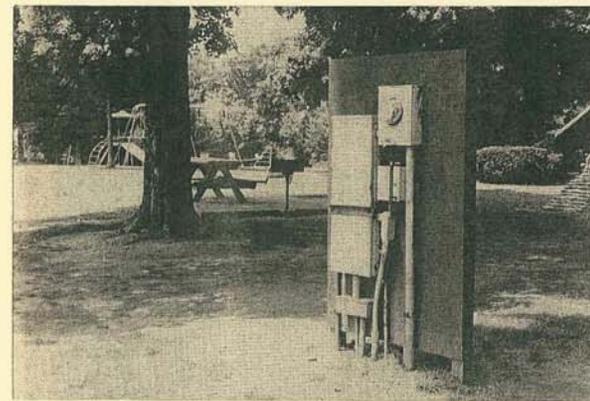
36. (Bottom) Utility and control box near the "teepee shelter" in Cherokee Park. (Landscapes, 1993)

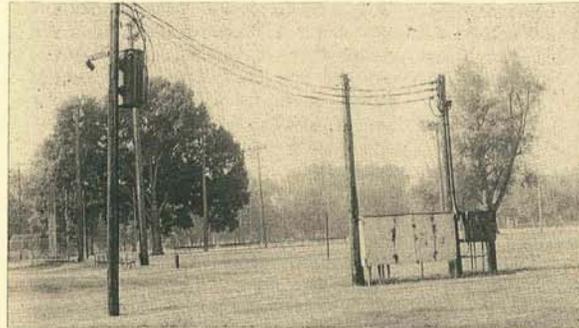
37. (Top) Highly visible control box and overhead utilities located in an open area in Shawnee Park. (Landscapes, 1993)

Today overhead electric wires are found along the parkways and within the parks. A plethora of wiring crisscrosses the parkways, while in the parks a density of wiring and related power supply boards are particularly obtrusive in two areas. The wiring control boxes and meter near the "teepee" shelter in Cherokee Park are mounted on a board [36]. In Shawnee Park's Great Lawn, a large number of baseball field light poles are supplied with power and the related boxed control system is placed in the middle of an open space [37]. These above ground systems are obtrusive and possibly a safety issue within the park landscapes.

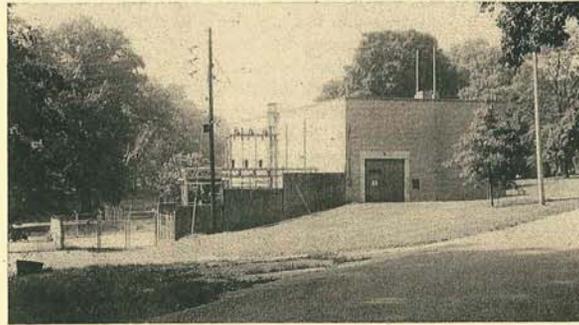
38. (Middle) Metropolitan Sewer District Pump Station within a fenced enclosure in Shawnee Park. (Landscapes, 1993)

At a minimum, the large MSD pump station structures should be screened with plantings. If the technology has improved and the size of the station can be reduced or the outdoor yard eliminated, these options should be explored. The small lift station at the Middle (Music) Concourse is directly centered in the proposed revitalized heart of the park. The removal of this structure or its replacement with a below grade vault should be fully explored.

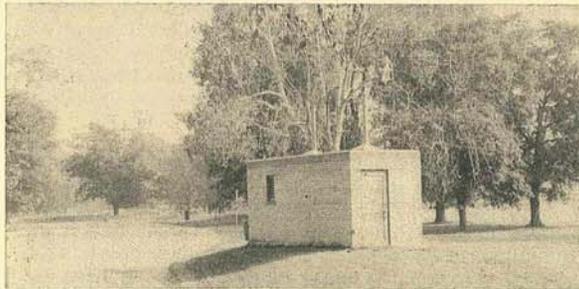
39. (Bottom) Pump lift station centered on Historic Middle Concourse in Shawnee Park, adds a non-park element and disrupts the intended spatial composition. (Landscapes, 1993)

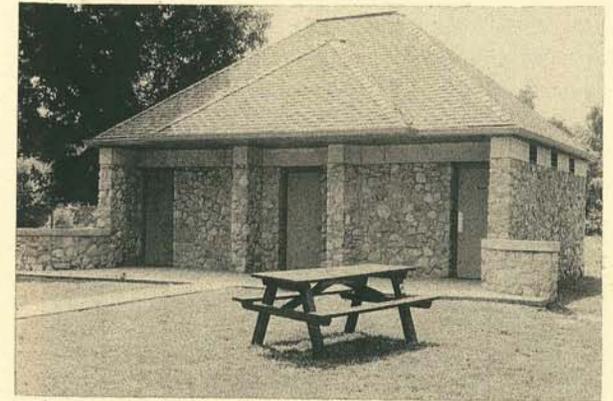
40. (Top) Recent addition of a limestone restroom near Hogan's Fountain in Cherokee Park; note open surrounding area making building obtrusive. (Landscapes, 1993)

Durability, fire and vandalism resistance are considerations in choosing materials which should be incorporated. The use of stone in cases of larger structures, as seen in the recent Hogan's Fountain area restroom, may be advisable [40]. This restroom, and other park buildings, fail to integrate effectively with the park environment. The combined shelter and restrooms at the Big Rock area demonstrates a preferred approach [41]. Siting of buildings in wide open areas draws attention to them, whereas placing them with a few large trees nearby and planting an open grove around them can create better scale relationships so that these park buildings do not seem large and isolated.

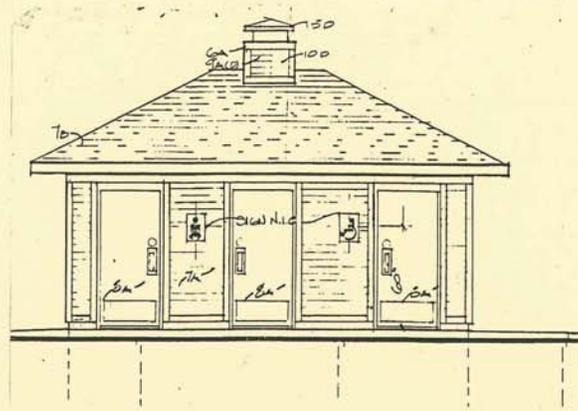
42a. (Top) Front elevation of recently constructed compost restroom showing three doors opening to individual bathrooms; plans by MRB Group, Rochester NY, 27 July 1992. (Monroe County Parks, Rochester NY)

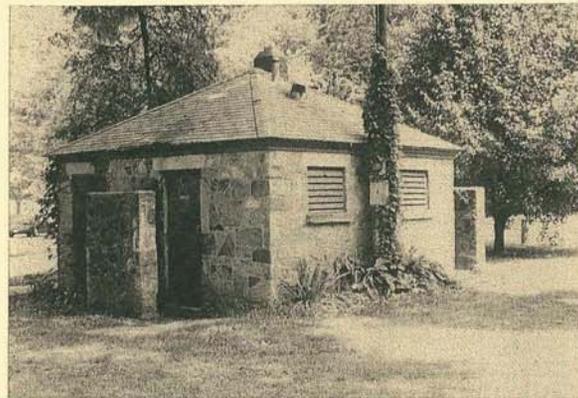
43. (Bottom) Golden sandstone restroom in Willow Park with light roof and dark doors and fascia boards, which could be painted a more appropriate color. (Landscapes, 1993)

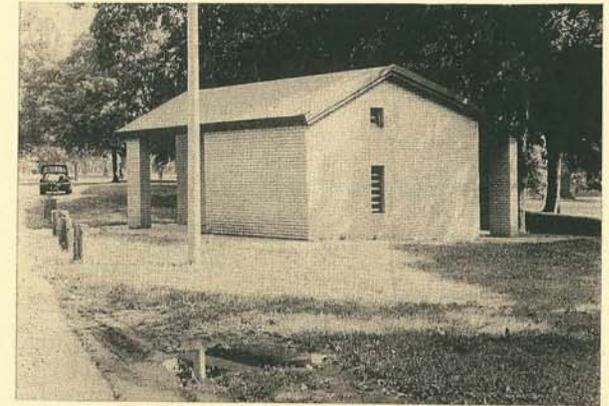
44. (Top) Buff brick restroom in Shawnee Park sited at edge of main loop drive in obtrusive location. (Landscapes, 1993)

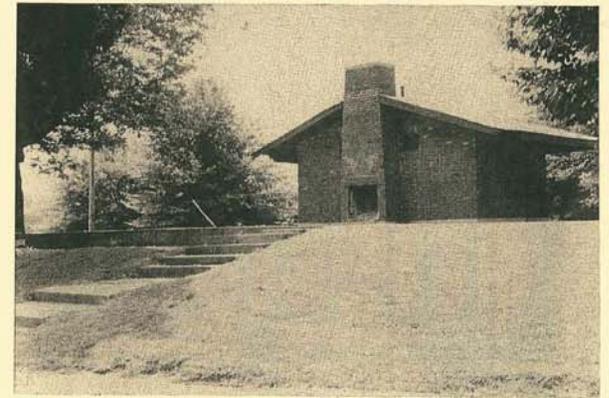
45. (Bottom) Remaining brick restroom on Barringer Hill, Cherokee Park; balance of shelter, with view over rolling landscape, has been removed; note former fireplace. (Landscapes, 1993)

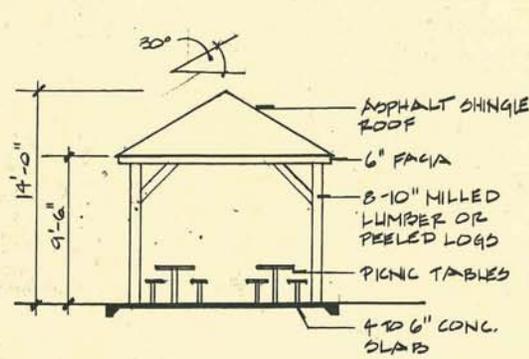
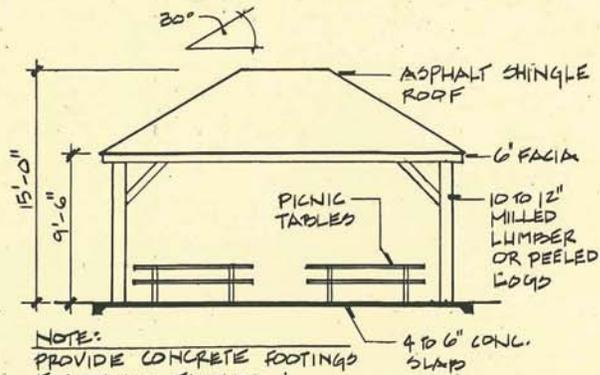
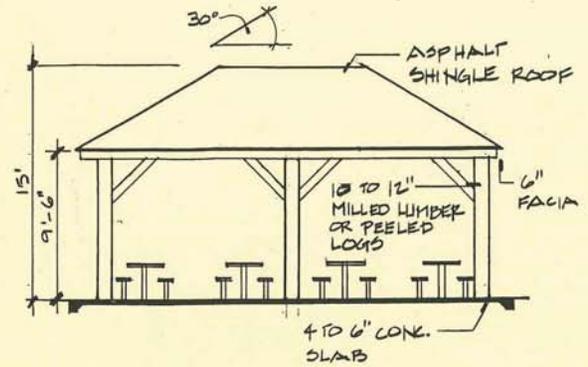
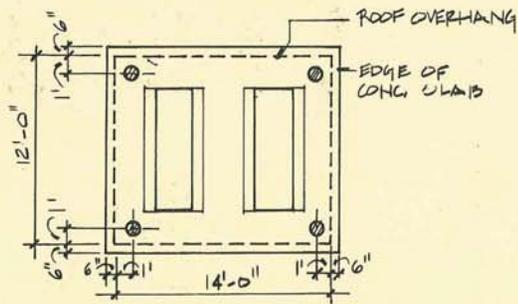
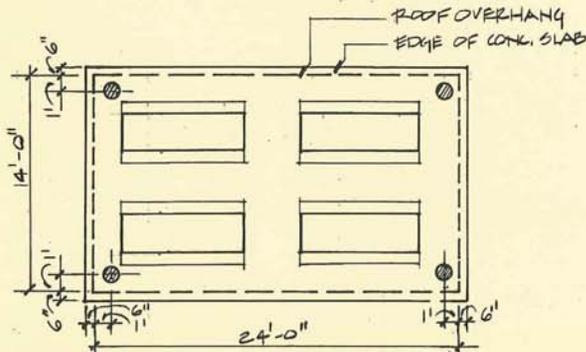
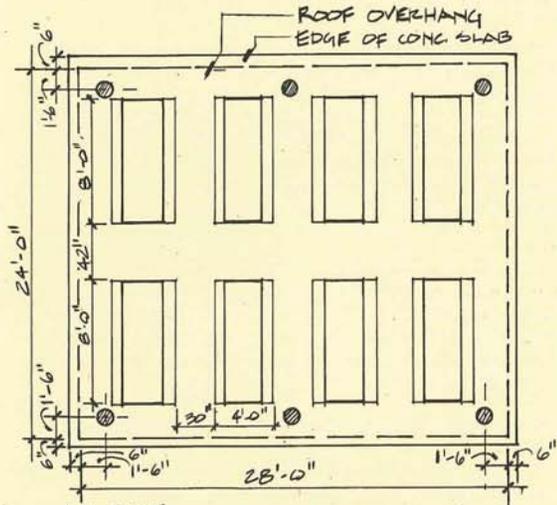
ELEVATIONS

NOTE:  
PROVIDE CONCRETE FOOTINGS  
FOR PICNIC TABLES &  
BENCHES AS REQUIRED.

SMALL  
2 TABLE (16 PERSONS)  
OVERALL SIZE 12 X 14'

MID SIZE  
4 TABLE (32 PERSONS)  
OVERALL SIZE 14 X 24'

LARGE  
8 TABLE (64 PERSONS)  
OVERALL SIZE 24 X 28'

PLANS
