# Chapter 8

## The Built Landscape

Prepared by Landscapes, Westport CT

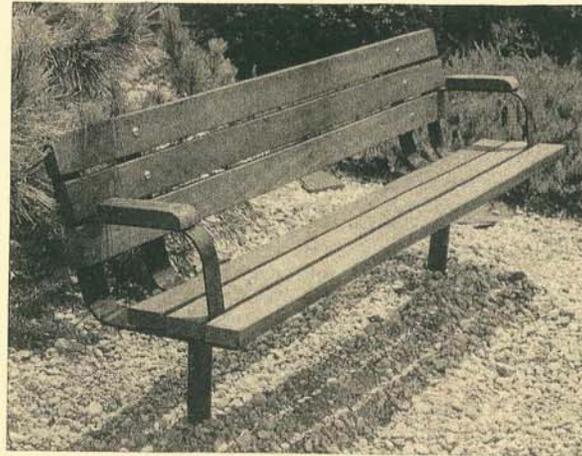
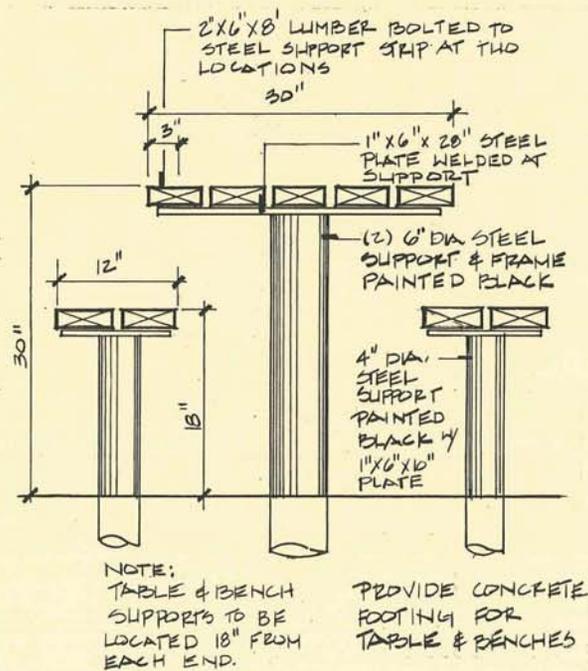
47. Picnic table and benches. (Landscapes, 1993)

New shelters, designed with large timber posts and shingled, hip roofs, are to be sited in picnic groves with existing and newly planted trees or at woodland edges with appropriate nearby plantings. In each park, shelters should be located near the active recreation complex and in passive areas, affording two kinds of picnicking experience. Three proposed shelter sizes are shown on the drawing entitled "Picnic Shelters (3 Sizes, Small, Mid-Size & Large)" [46]; the eight-table seats about sixty-four people, the four-table seats thirty-two people and the two-table seats sixteen people. Four large timber or peeled-log supports are indicated for each shelter. The size of each shelter is tailored to the number of tables and each configuration provides wheelchair access through and to table ends for wheelchair seating. These shelters have tables and benches installed in the concrete slab. The design, shown in the drawing "Picnic Table" [47], is durable and will be easy to repair with standard 2" x 6" x 8' lumber.

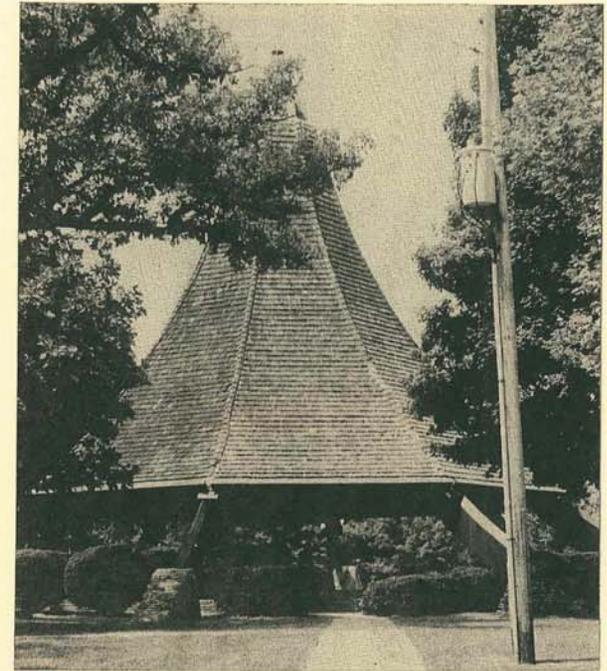
48. (Top) Large "teepee" roofed picnic shelter in Cherokee Park, which is too large and out of character for the area. (Landscapes, 1993)

Picnic shelters of various sizes and materials are found in each park. The largest and therefore most out of character is the "Teepee" shelter near Hogan's Fountain in Cherokee Park. This six-sided structure dominates the area with its unique form and very large roof rather than blending into the park surrounds. For its size it holds a relatively small number of tables, fitting between 12 to 24 depending on layout. Figure [48] shows this structure with clipped-yew shrubs around it and a power pole with transformer in front of it. Note also the urban and formal character of the straight concrete sidewalk providing access.

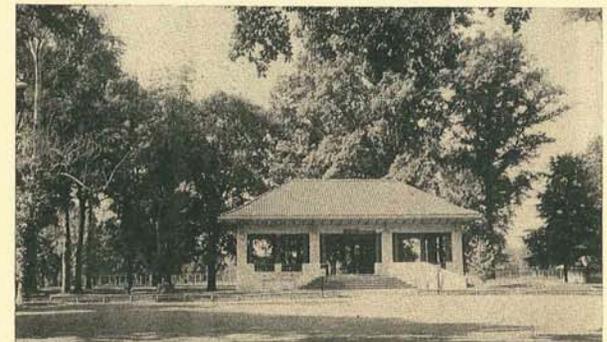
49. (Bottom) Two-story painted combination picnic shelter and restroom in Shawnee Park, which dominates the park landscape because of its beige stucco walls and bright red roof. (Landscapes, 1993)

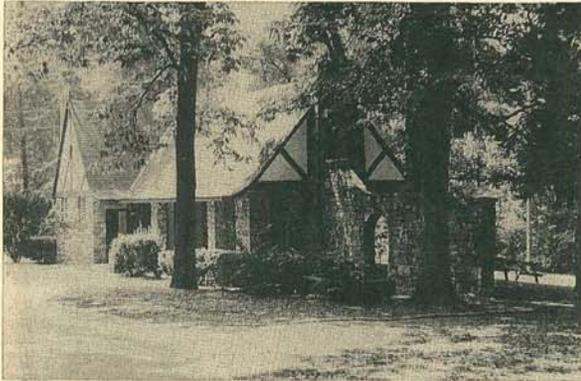
50. (Top) Jacob's Lodge, an open-sided wooden picnic shelter and restroom on the Burnt Knob of Iroquois park. (Landscapes, 1993)

Jacob's Lodge on the Burnt Knob of Iroquois Park is also a combined restroom and open picnic pavilion [50]. Built of stone and stucco in a Tudor style, it would blend more effectively into the park if the stucco and trim colors were closer to the values and tones of the stone. Also on Burnt Knob, two flat-roofed metal structures serve as picnic shelters, one in the open meadow, another in the nearby woodland. These structures are incompatible with the park landscape, and the one in Summit Field is especially obtrusive.

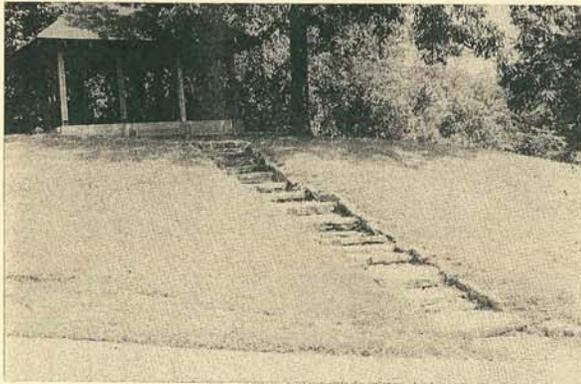
51. (Bottom) Picnic shelter with simple timber-frame and hip roof, with sandstone stairs leading up to it in Iroquois park. (Landscapes, 1993)

In Iroquois Park, there are also five open wooden shelters of varying sizes, with shingled hip roofs. Figure [51] shows the South Lookout shelter and related stone steps in dappled shade at the edge of the open woodland. These shelters are all in serviceable condition. The one nearest the main entry drive is seldom used and has moss on the roof. These simple, rustic shelters blend effectively in the park environment. Made of the materials called for by the Olmsted firm in their correspondence on the carriage shed, they are the model for additional park picnic shelters.

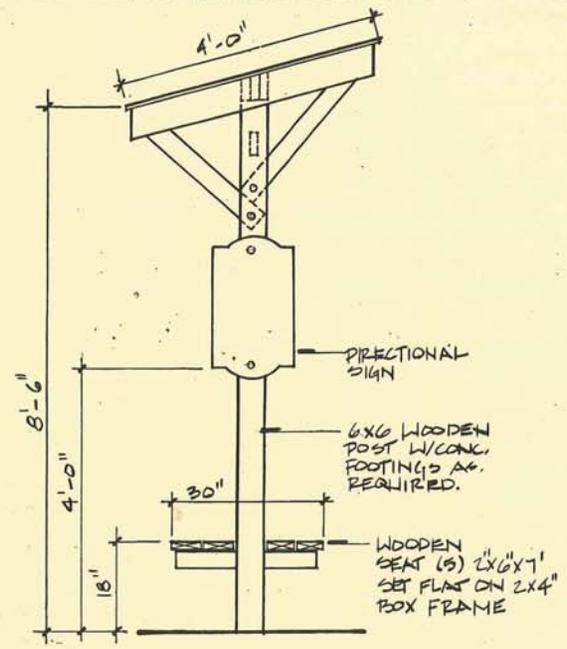
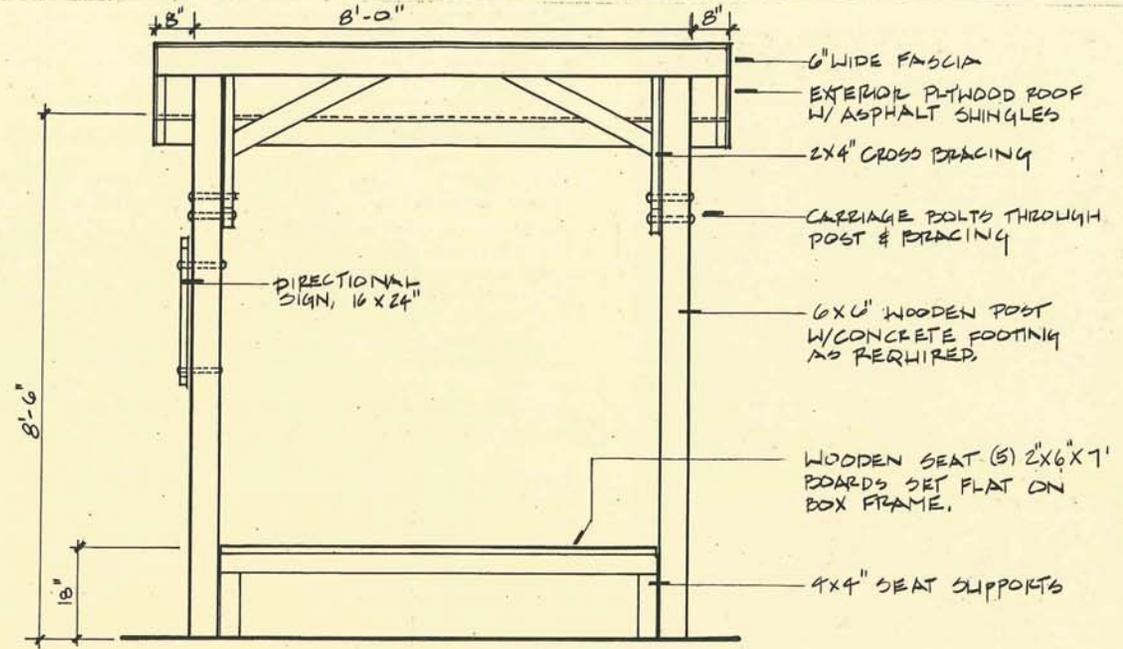
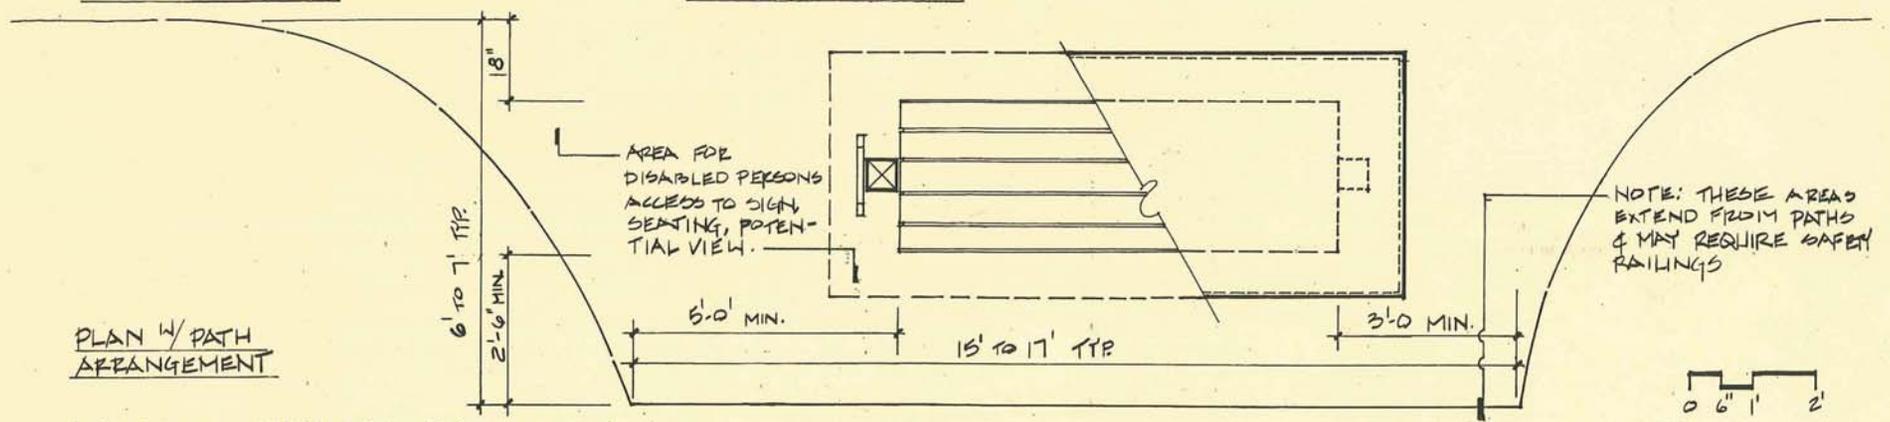
WAYSIDE SHELTER W/ BENCH & SIGN

SIDE ELEVATION

FRONT ELEVATION

PLAN W/ PATH ARRANGEMENT

52. Wayside shelter. (Landscapes, 1993)

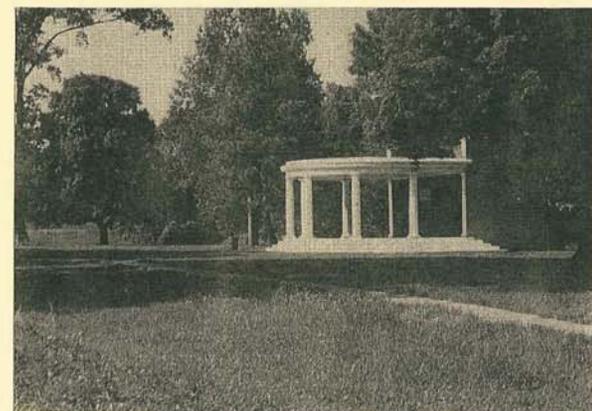
54. (Bottom) Bandshell in Shawnee Park used for small-scale events during the summer season; requires drainage and circulation improvements. (Landscapes, 1993)

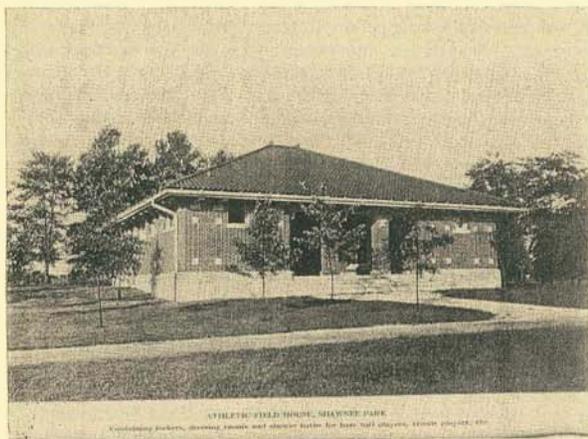
ATHLETIC FIELD HOUSE, SHAWNEE PARK  
 Containing parking, dressing rooms and shower bath for base ball players. 1918. (Private Collection, Charles Birnbaum)

55. (Top) Athletic field house (Ball House) in Shawnee Park, from Yearbook of the Board of Park Commissioners of Louisville, Kentucky, 1918. (Private Collection, Charles Birnbaum)

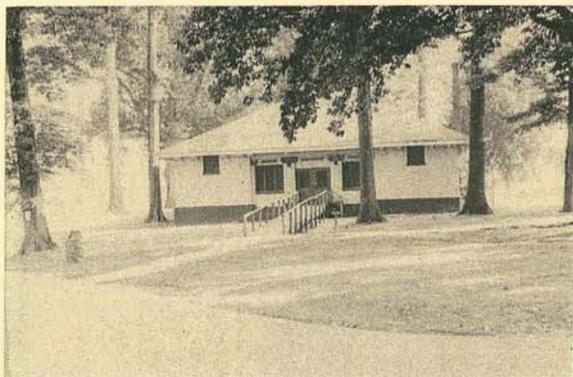
56. (Bottom) Ball House in Shawnee Park, with light painted walls and asphalt-shingle roof that does not blend into the surrounds as did the historic detailing of brick walls and tile roof. (Landscapes, 1993)

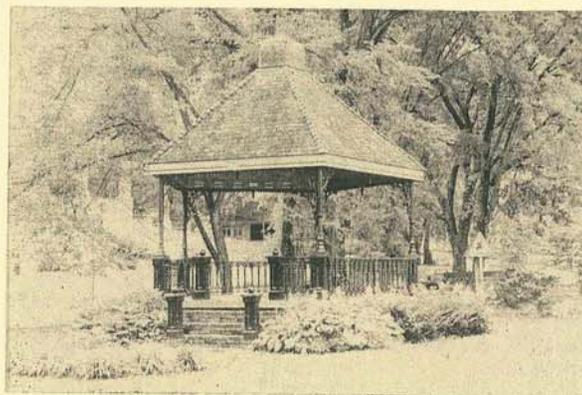
57. (Top) Decorative gazebo in Willow Park with iron railing and steep, four-sided roof, a recent addition to this formerly simple greenspace. (Landscapes, 1993)

Gazebos in outdoor spaces are a trend in recent years. Two have been added to the parks at Willow Park and Shawnee, near the Lily Pond. Figure [57] shows the Gazebo at Willow Park. Raised on a brick foundation, a decorative iron railing frames the floor while corner posts with brackets support the steeply pitched roof. The foundation is planted with hosta clumps. The style and detailing of this small outdoor structure is attractive but not in keeping with the Olmsted guidance for park buildings. In addition, no building was intended for this small greenspace along Cherokee Parkway.

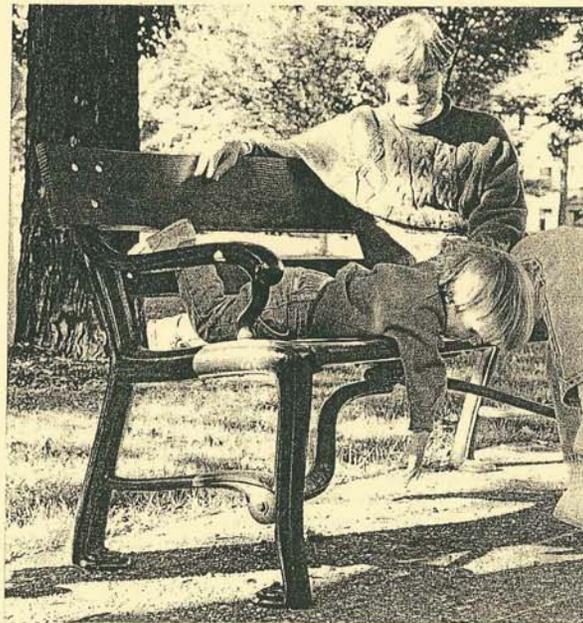
58. (Bottom) The Albany bench. (Washington Park Conservancy, Albany NY)

A unique approach to a park bench was undertaken by the Washington Park Conservancy, Albany, New York. They wanted the bench for their historic park to have some of the character of the historic ones but also wanted a new design. Their Conservancy commissioned a noted local sculptor to design their bench, using a cast metal frame and wood slats [58]. While wood slats can be vandalized, they are more comfortable and easier to replace than metal ones. The metal frames were fabricated by a local metal casting shop under contract. Parks staff installed the frames and attached the wood slats. The Albany bench has become a city favorite and is being used in other public spaces. Louisville may want to approach the design of their own park bench in the same way, developing a pleasing design that can be repaired and maintained.

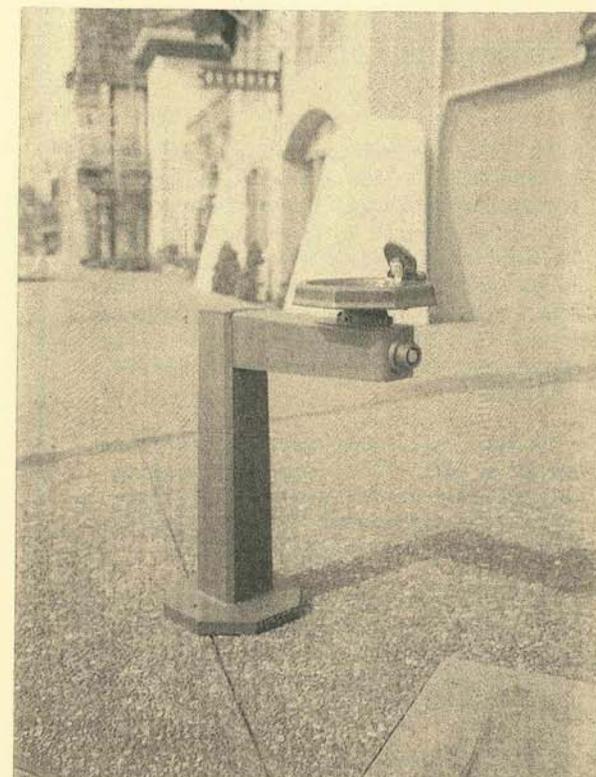
59. Murdoch handicapped accessibility water fountain set on metal L-shaped post along a walkway. (Landscapes, 1993)

Drinking fountains should be located within the parks in each activity area. Installation on the exterior wall of restrooms is one of the best solutions for plumbing efficiency. There should be a paved area around the fountain. Drinking fountains should not be placed in an open lawn area as is the present practice. Figure [59] shows a Murdoch handicapped-accessible fountain which can be installed on a post, as shown, or on a building wall. Drinking fountains along the parkways are not necessary.

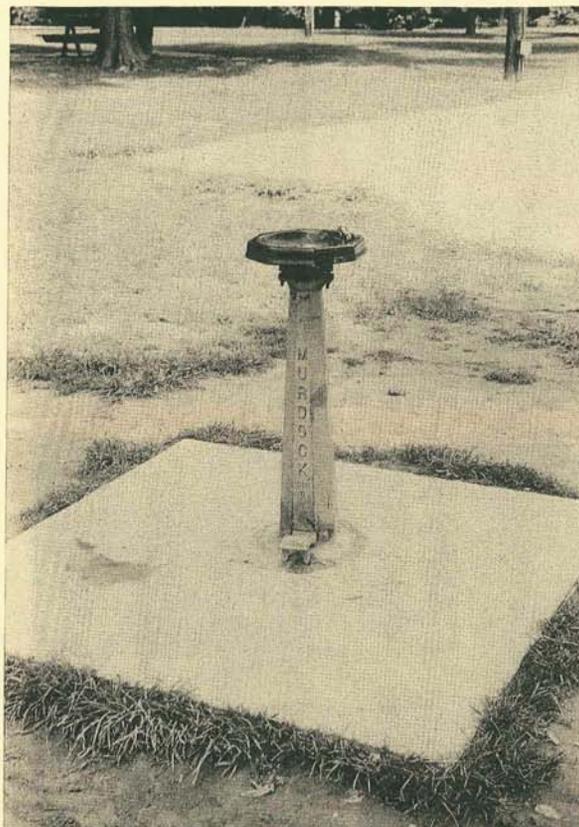
61. Murdock water fountain set onto five-foot-square concrete pad in the middle of an open lawn area. Notice the compacted bare earth surrounding the fountain. (Landscapes, 1993)

Drinking fountains were also found in the parks based on correspondence from the Olmsted Brothers dated 1908. They remarked that the drinking fountain locations were not suitable and explained that they should never be placed in the middle of a lawn because they would . . . be conspicuous and out of harmony with the lawn, and besides short-cut paths are liable to develop in connection with them and the surface of the lawn is often destroyed . . ." as is seen in the current photograph of a drinking fountain in figure [61].

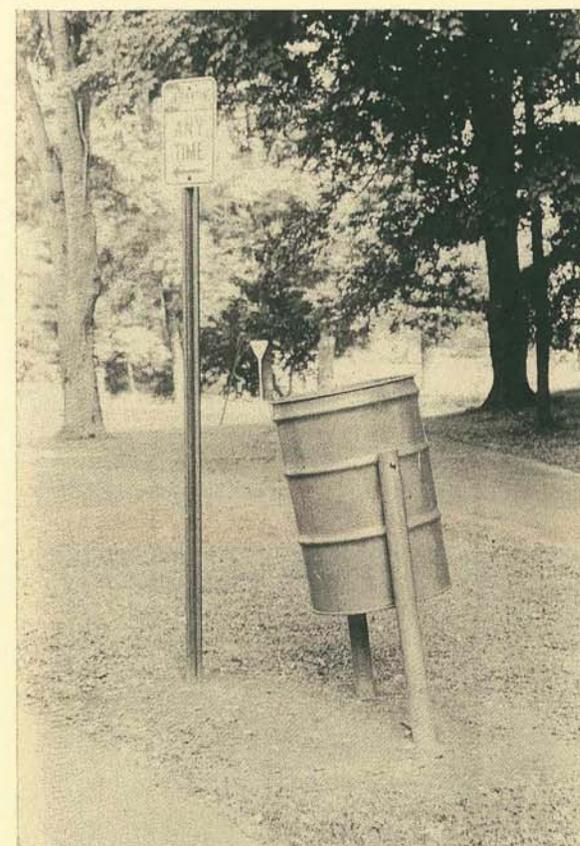
62. Typical painted metal trash barrel set between two metal posts shown along drive in Shawnee Park. These trash cans can be easily emptied and are usually located in picnic areas and activity zones. (Landscapes, 1993)

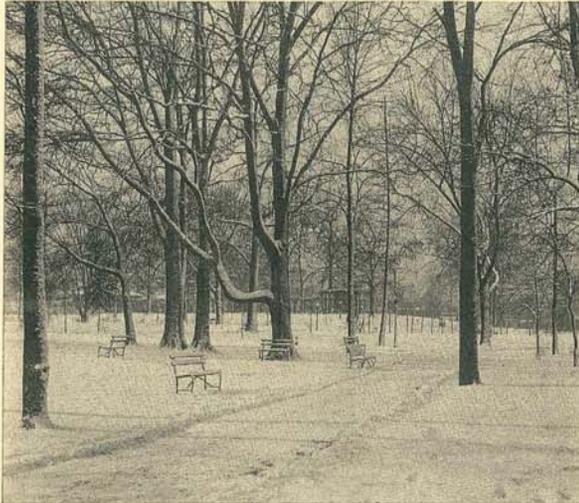
63. (Top) Historic view of park benches in Central Park, c. 1926. (University of Louisville, Photographic Archives, Caufield & Shook Collection)

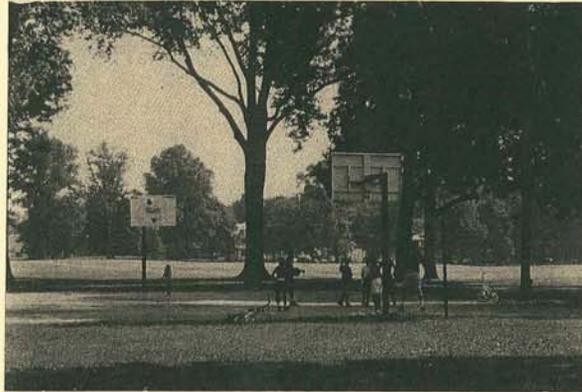
67. (Top) Small basketball court in Shawnee Park used for casual play. (Landscapes, 1993)

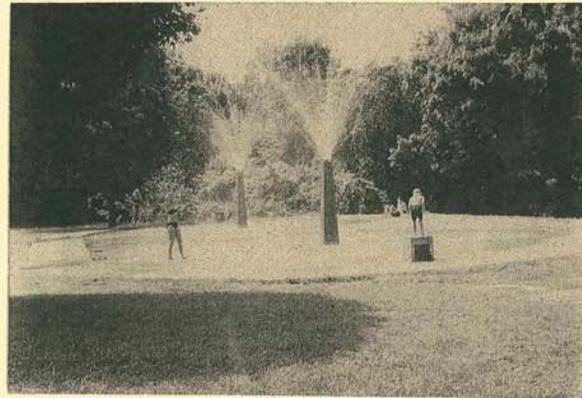
68. (Bottom) Oval spray pool at the Hogan's Fountain area in Cherokee Park. (Landscapes, 1993)

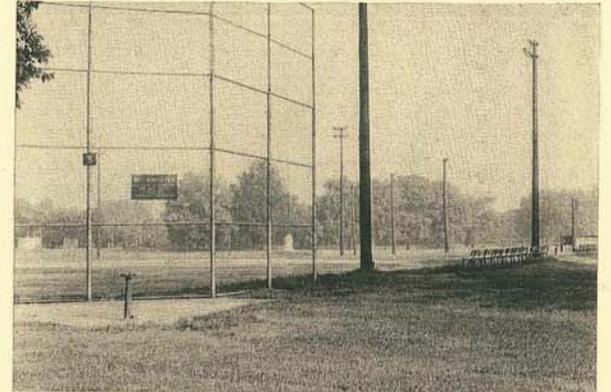
69. (Top) Duffy Baseball Field in Shawnee Park with associated backstop, drinking fountain, benches and lights. (Landscapes, 1993)

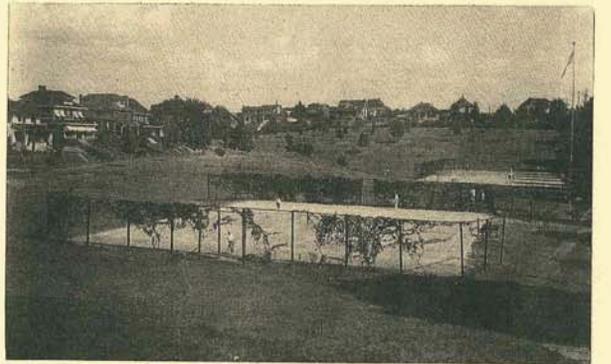
70. (Bottom) Vine-covered fences on only two sides of the tennis courts in Tyler Park, c. 1921. (University of Louisville, Photographic Archives, Caufield & Shook Collection)

Tennis and basketball courts also require careful siting. In correspondence regarding tennis courts in Shawnee Park, John C. Olmsted remarks on the use of turf plots for tennis indicating that the Superintendent "see to it that they are not abused." They also suggest that the courts should be placed to the west of the picnic grove so that some shade is available. Note that these were grass courts and when not in use did not disrupt the expanse of greensward. Today's courts with paved surfaces and four sides of fencing are much more visually intrusive. Figure [70] shows two paved tennis court groups with two courts each in Tyler Park with fences on two sides and angled end sections. Vines are growing up the fences.

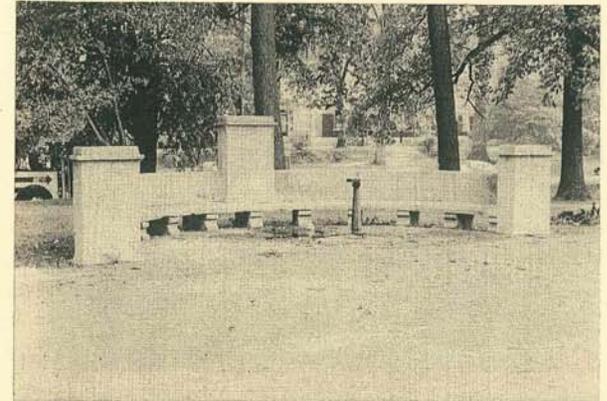
71. (Top) Waller Memorial Bench in Shawnee Park, showing deterioration of the dignified setting with the addition of a modern drinking fountain and the loss of the surrounding foot path. (Landscapes, 1993)

**Conditions:** Minor graffiti; generally in good condition, some minor surface losses of stone [71]. Setting probably included a more decorative fountain rather than the standard drinking fountain now located in the center. Documentation for this earlier piece should be sought. The path system around this memorial bench blends in with the adjacent drive and is unclear and unmaintainable. It should be reclarified as a dignified setting for this piece.

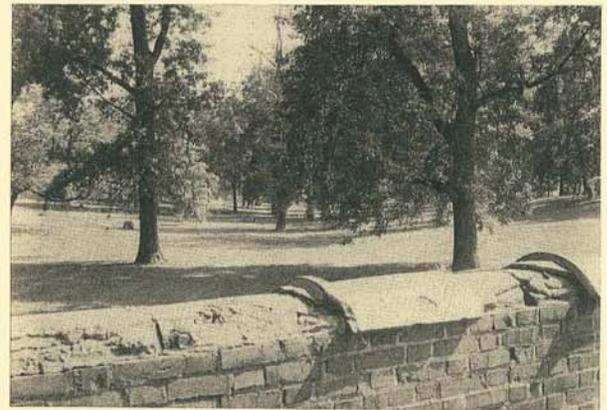
72. (Bottom) Detail of deterioration to brick wall and terra cotta tile cap on Chestnut Street Bridge, Shawnee Park. (Landscapes, 1993)

**Materials:** Brick with terra cotta tiles as cap. Figure [73] is the original Olmsted, Olmsted and Eliot, Landscape Architects, Shawnee Park Plan of Bridge at Chestnut Street Entrance, July 12, 1893. See figure [72] for detail of deteriorated cap.

**Conditions:** Capstones are partially missing and broken. Brick facade walls are showing signs of deterioration.

**Treatment:** Replicate and replace capping tile, repoint brick walls. Review structure for engineering deficiencies.

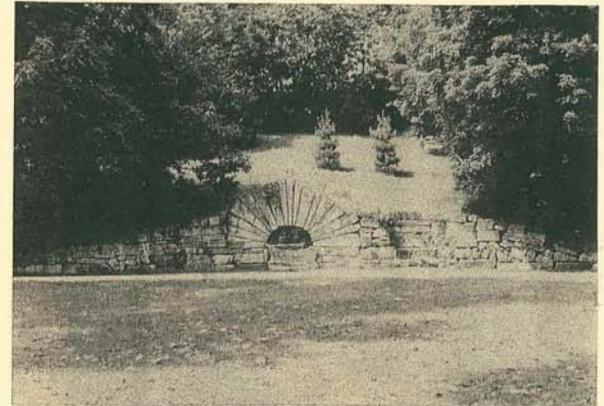
78. (Top) Christensen Fountain in Cherokee Park, with invasive plant growth and some missing or damaged stones. (Landscapes, 1993)

*Conditions:* Some minor losses to the wider ends of the stone spokes in the center of the monument. There is extensive and pervasive biological growth (higher plant forms). The grade encroaches on the base on the left and the right. Cracks appear in some of the base stones. Some surface erosion can be seen on the Christensen sign. Extensive water seepage through the back of the monument is noted. Many stones are either missing or have fallen from their original positions but are still extant at the sight. The boat-shaped trough has been recently replaced with a precast system. Some stones which form steps on the right are no longer in their proper places.

*Treatment:* Remove biological growth (both lower and higher forms; manually for higher forms and with medium pressure water for lower forms) and reset fallen stone elements including area of steps on the right. Remove encroaching grade along the bottom in the front. Some larger gaps must be refilled with a similar stone to ensure stability of the wall. These would be smaller pieces essentially to fill gaps. This should be done to match historic conditions and in keeping with old photographs of the site. Remove encroaching earth in the back of the monument and regrade as a gentle grass swale to allow water to run along the sides and away from the back.

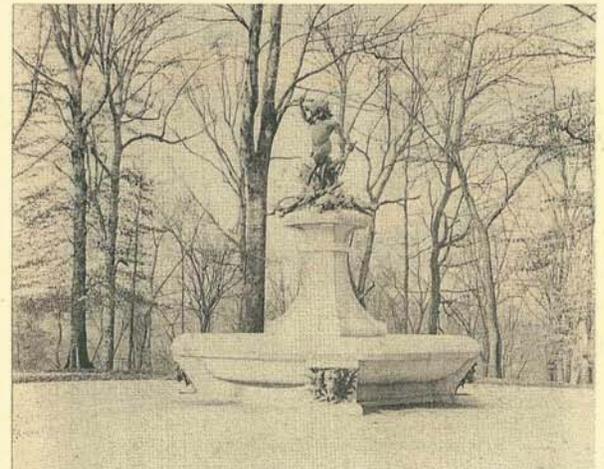
79. (Bottom) Historic view of Hogan's Fountain in Cherokee Park, with turtles and dog faces in place, c. 1906-1915. (University of Louisville, Photographic Archives, Claude C. Matlack Collection)

*Materials:* Cast bronze and granite. Figure [79] is an early view of the fountain in winter with the original turtles, dogfaces and cattail reed in the hand of the figure, all of which are removed or missing today. Other historic views are also available to assist in the rehabilitation effort.

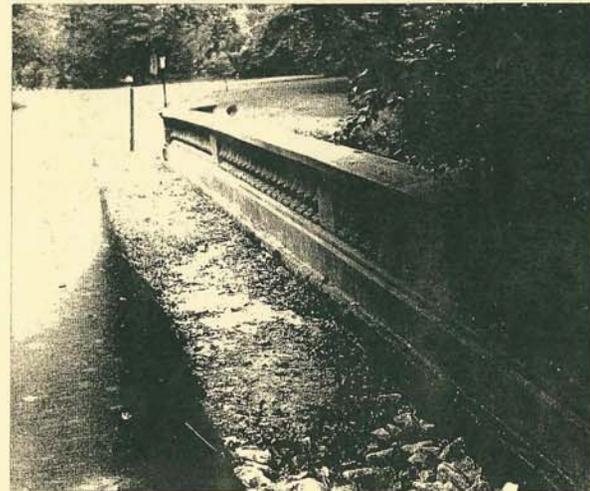
80. (Top) Significant erosion of balustrade at Hert Memorial Bridge, Cherokee Park. (Landscapes, 1993)

81. (Bottom) Channeling of water along the paths on both sides of the Grenoweth Bridge, Cherokee Park, is causing erosion to the bridge foundation. (Landscapes, 1993)

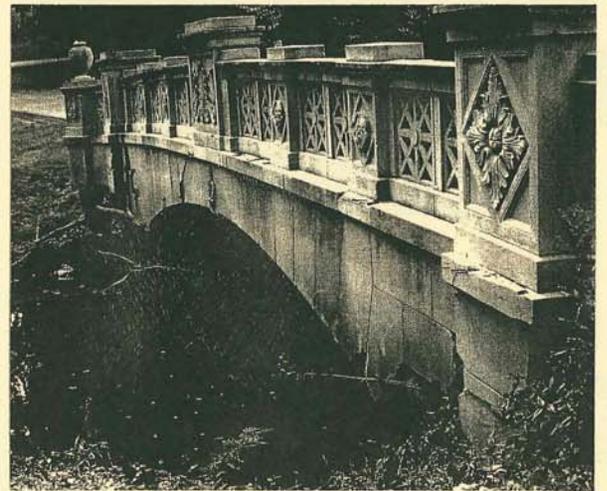
83. (Bottom) Creek facade of Bernheim Memorial Bridge, Cherokee Park, showing extensive loss of stone. (Landscapes, 1993)

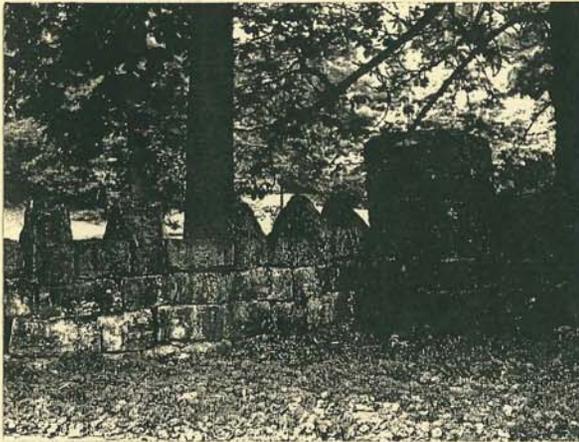
84. (Top) Typical wall section of Grinstead Drive entrance, Cherokee Park, with wide mortar joint and cracks in stone. (Landscapes, 1993)

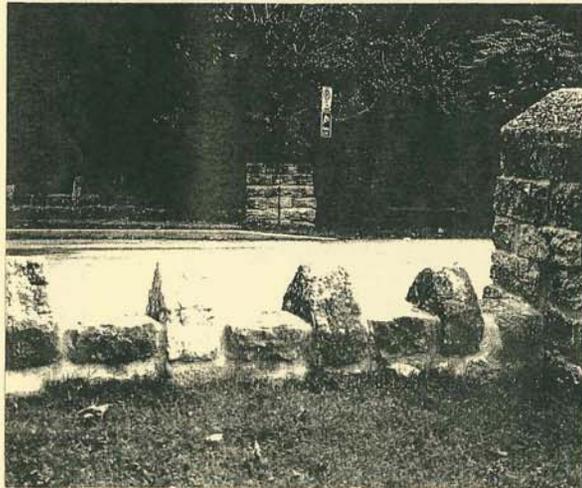
85. (Bottom) Detail of dry-laid, toothed stone wall at Grinstead Drive entrance, Cherokee Park. (Landscapes, 1993)

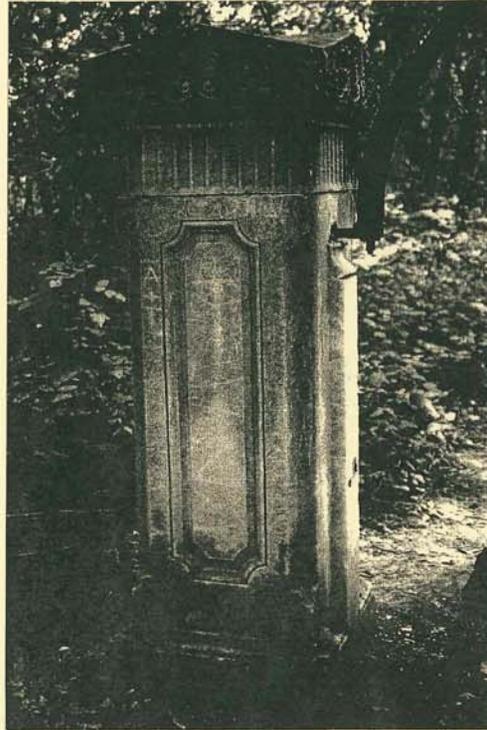
86. Minor surface erosion of one of the pair of piers at gate for Barringer Hill, Cherokee Park. (Landscapes, 1993)

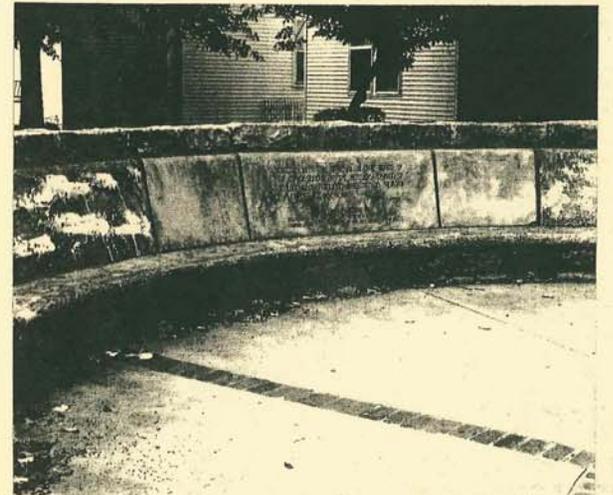
88. (Bottom) Partial view of replaced center stones of Wayside park, Wheelman's Bench. (Landscapes, 1993)

*Conditions:* Stone is soiled; extensive graffiti. Pointing is either poorly done or in poor condition. There are several patches to the limestone done in cement. Other smaller pieces are missing. Several long but minor cracks are found in the stone.

*Treatment:* Previous efforts to repair are not successful; inscription stone replacement does not match original and should be replaced to match in the future; complete repointing with 1:1:6 mixture. All losses of the stone including those already patched in cement should be replaced with dutchmen in a matching stone. The entire surface should be cleaned with medium pressure water including the removal of the graffiti using solvent based cleaners if necessary. The intended bicycle parking stands along the back of the bench should be investigated and

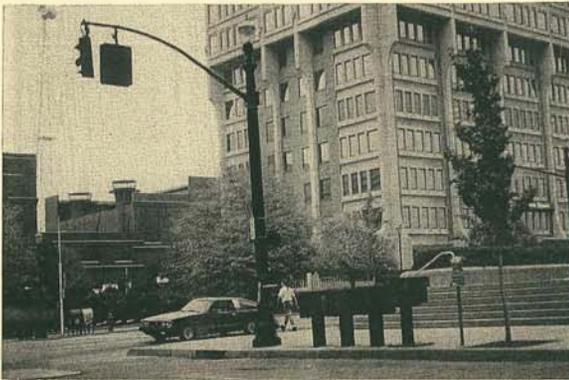
89. (Top) Dual-purpose pole (not luminaire) and traffic light along street in Louisville that is recommended for use on the Parkways. (Landscapes, 1993)

Along the parkways, a light that is lower than the cobra head or shoe box and higher than the Cherokee Park light is recommended. The system developed for downtown Louisville, including single and double light poles and traffic signals is a good model for the parkways. Views of these elements are included as figures [89, 90 & 91], with the traffic signal, single luminaire pole and double luminaire pole respectively. The single light has a 16-foot height to the center of the luminaire. The downtown lighting system began to be installed about seven years ago and while there were some initial problems, the system is working effectively now. Recently an improvement on the refraction of the acorn luminaire has been under discussion. The luminaires use 150 watts or 250 watts of power. An individual light pole and luminaire costs about \$1,600 while the fixture with the signal arm is about \$3,000. They are spaced 70 feet on center for six-lane (60 to 72 feet wide) streets and at 100 feet alternating on four-lane (40 to 48 feet wide) streets.

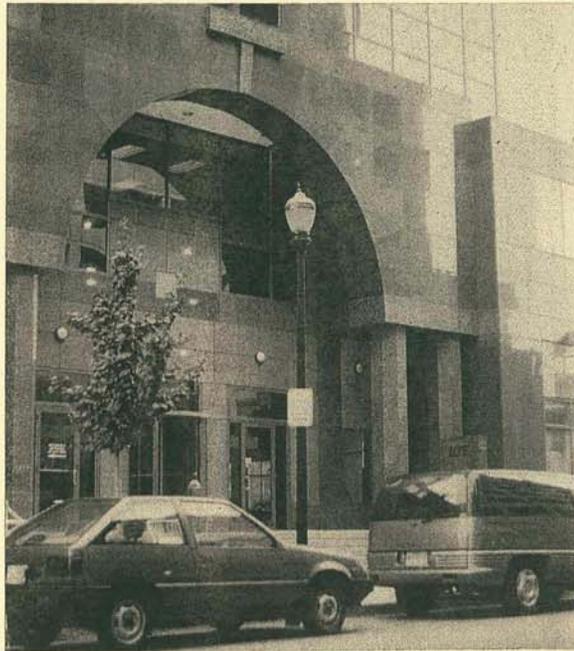
90. (Bottom) Single street-lighting pole (not luminaire) along downtown Louisville street that is recommended for use on the Parkways. (Landscapes, 1993)

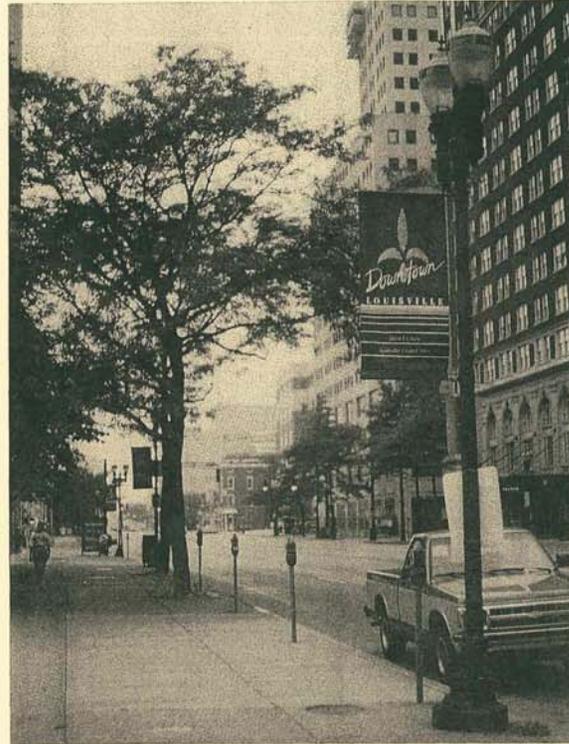
91. Double street-lighting (not luminaire) pole along street in Louisville that is recommended for use on the Parkways. (Landscapes, 1993)

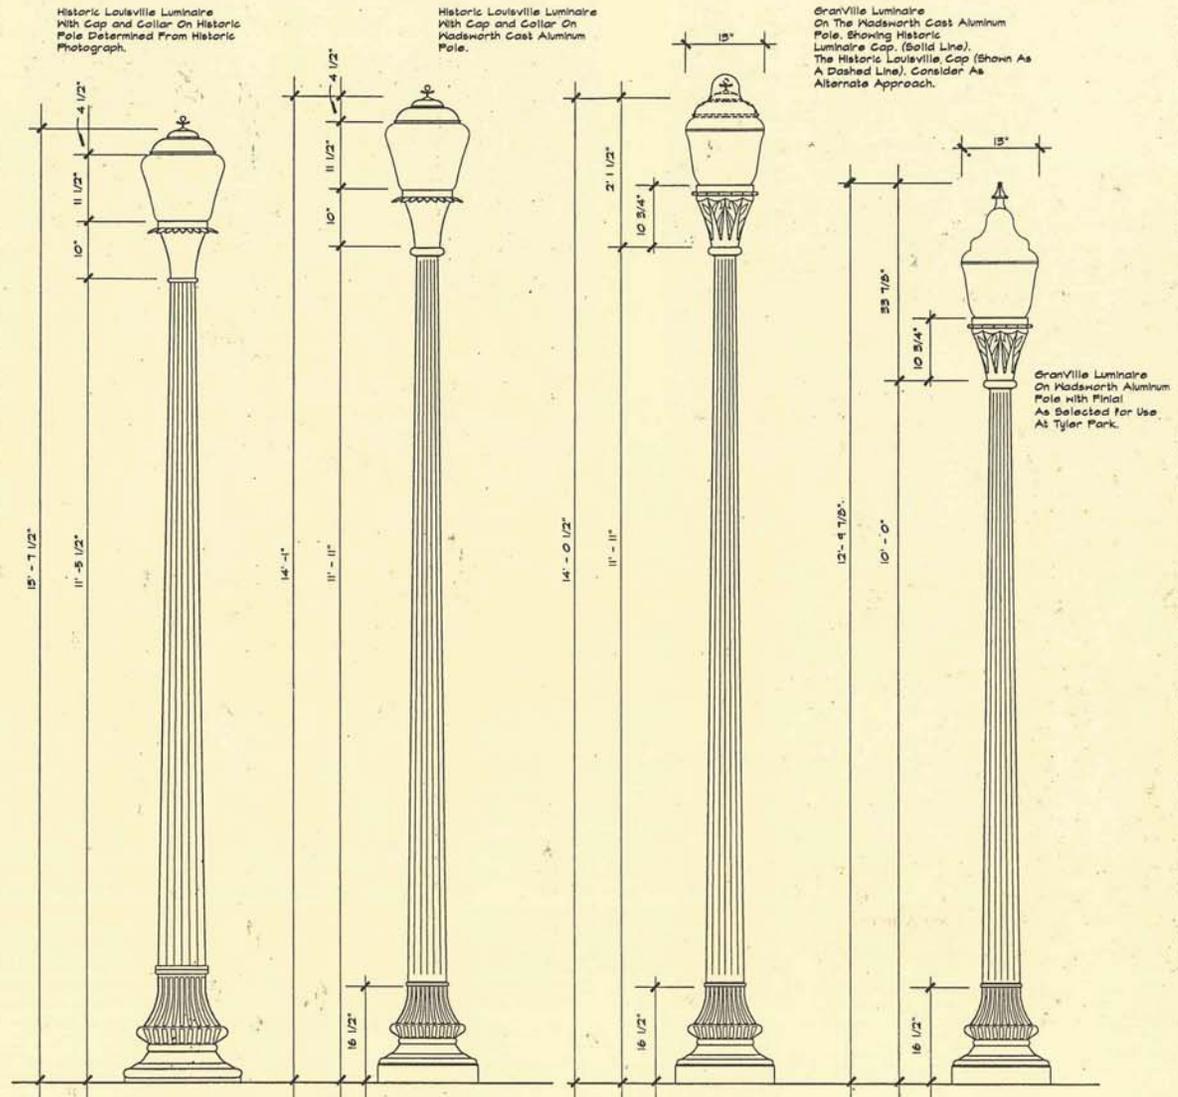
92. Drive lighting, standard fixtures. From left to right: (1) historic luminaire as determined from historic photograph, with 13'-7 1/2" height; (2) historic luminaire with Wadsworth aluminum pole, with 14'-1" height; (3) and (4) replacement luminaire with Wadsworth Aluminum pole, with 14'-0 1/2" and 12'-9 7/8" overall fixture heights. (Landscapes, 1994)

This pole and luminaire is shown in [92] as a comparison to the historic pole shown in [98]. The pole in use downtown matches the one shown in the historic view. The use of this pole with the luminaire shown in the historic view is recommended for use along the parkways, most of which have 40-foot-wide main drives. The development of this luminaire into an effective parkway light can be worked out with lighting manufacturers. A spacing of about 100 to 120 feet, alternating, would be desirable. The quality of the light should be primarily spreading outward and downward rather than upward. The drive surface and the adjacent pedestrian and multi-use paths should be illuminated. The use of the solid cap may be helpful in refracting and spreading the light effectively. The proposed luminaire will need to be developed and tested in collaboration with a lighting company as a custom fixture. Once it is finalized this lighting system should be phased in over time.

The entire vocabulary of lights recommended for park use and parkway drive and signal use is shown in elevation on the drawing, "Drive Lighting Standard Fixtures" [92].

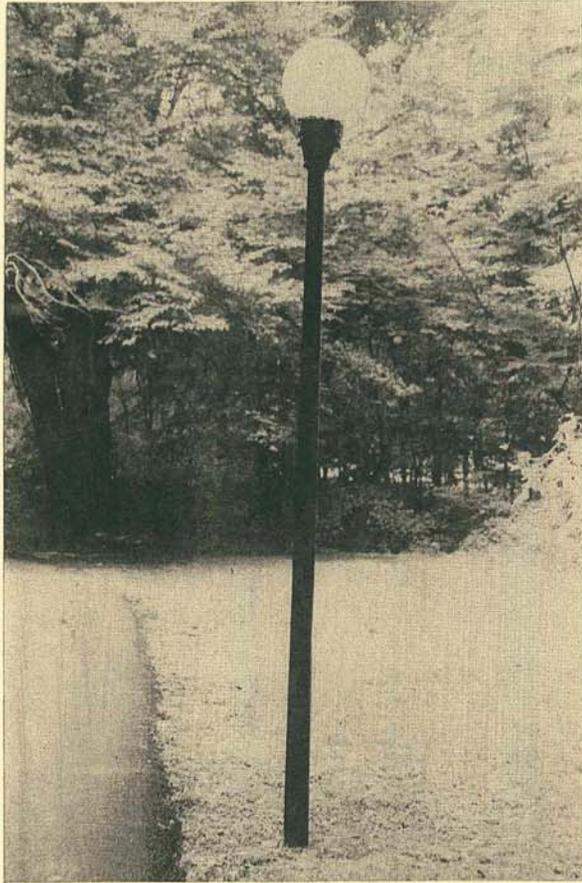
93. Fiberglass light standard with plastic globe luminaire leaning precariously in Cherokee Park, (Landscapes, 1993)

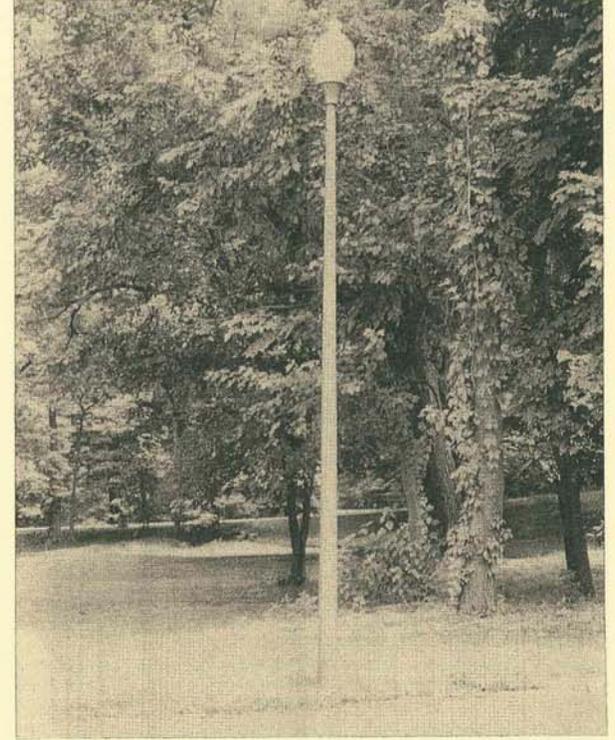
95. Eighteen-foot fiberglass post, which can be easily shaken, used in Iroquois Park near the basketball court and playground. (Landscapes, 1993)

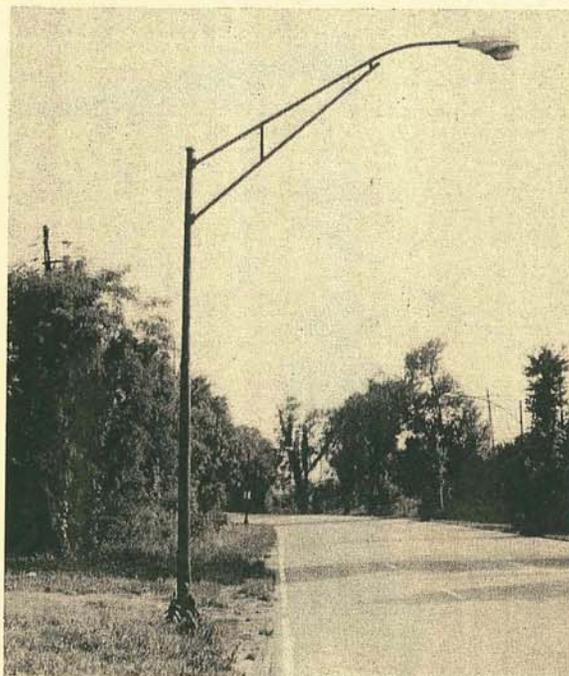
96. A double-light mast variation of a cobra head light on a metal pole along the Western Parkways. (Landscapes, 1993)

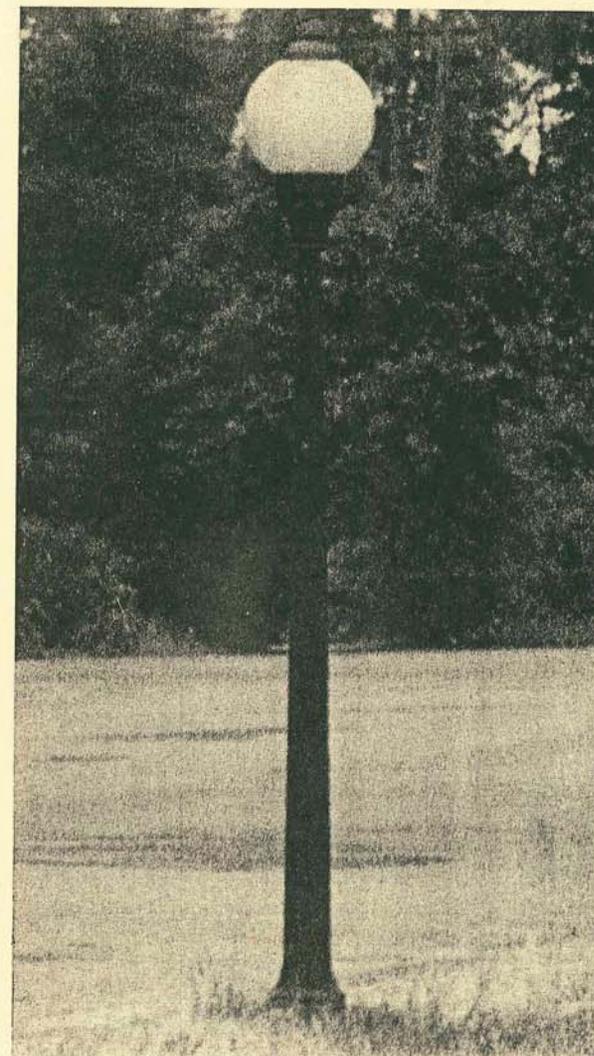
97. Historic view of eight-foot fluted light standard with round glass globe in Cherokee Park, c. 1921. (University of Louisville, Photographic Archives, Caufield & Shook Collection)

Details of two views of historic light posts are shown in figures [97& 98]. The first is the Cherokee Park light that is still found in the park today. It was also installed along parts of Eastern, Cherokee and Southern

Parkway according to historic photographs. Note that the round globe has a top with two domes. The post, which is about 8-foot tall, is a graduated, fluted form with a round base and a round top with curled leaf decorations. The second light, shown in front of a drugstore, has a more finely fluted, graduated post, a wider base and a scalloped top. It is about 12- or 13-foot tall with a 16- or 18-inch luminaire and cap and finial. Other historic views show a drop globe, which is enlarged in [99], that was extended rather tenuously on wires, out over the street. Each of these luminaires was made of glass.

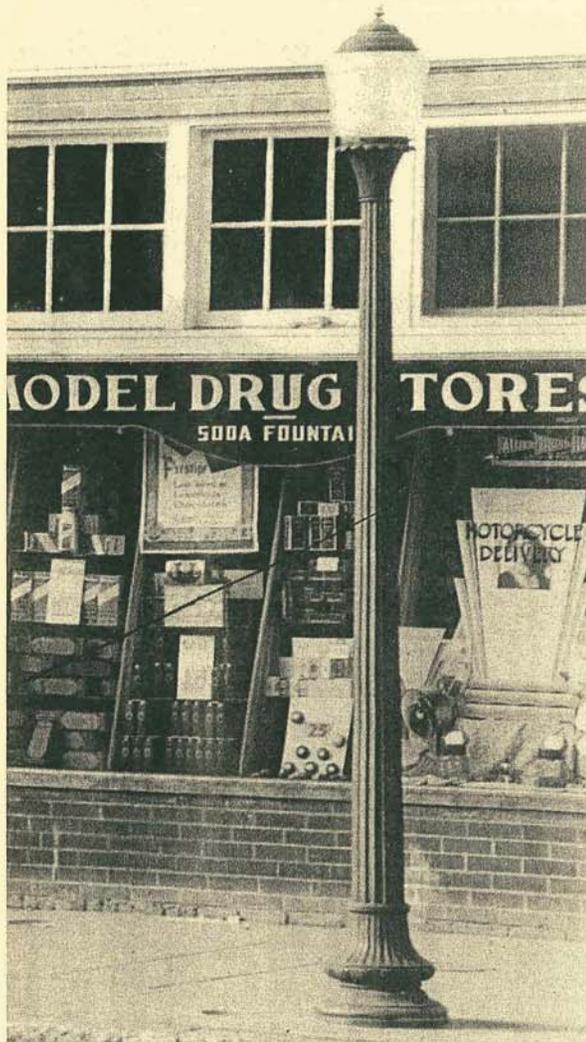
98. Historic view of twelve-foot fluted light standard with a wide base and a scalloped top. (University of Louisville, Photographic Archives, R.G. Potter Collection)

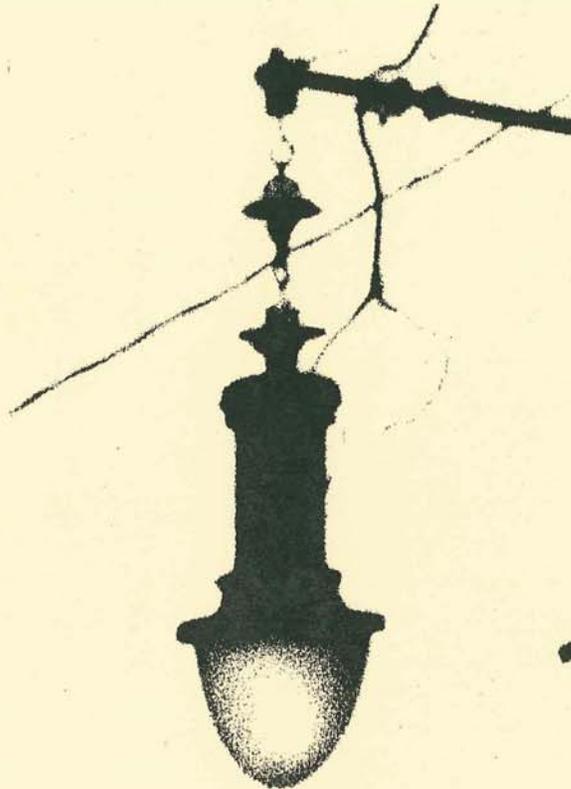
99. Close-up of drop glass globe on historic street light. (University of Louisville, Photographic Archives, Caufield & Shook Collection)

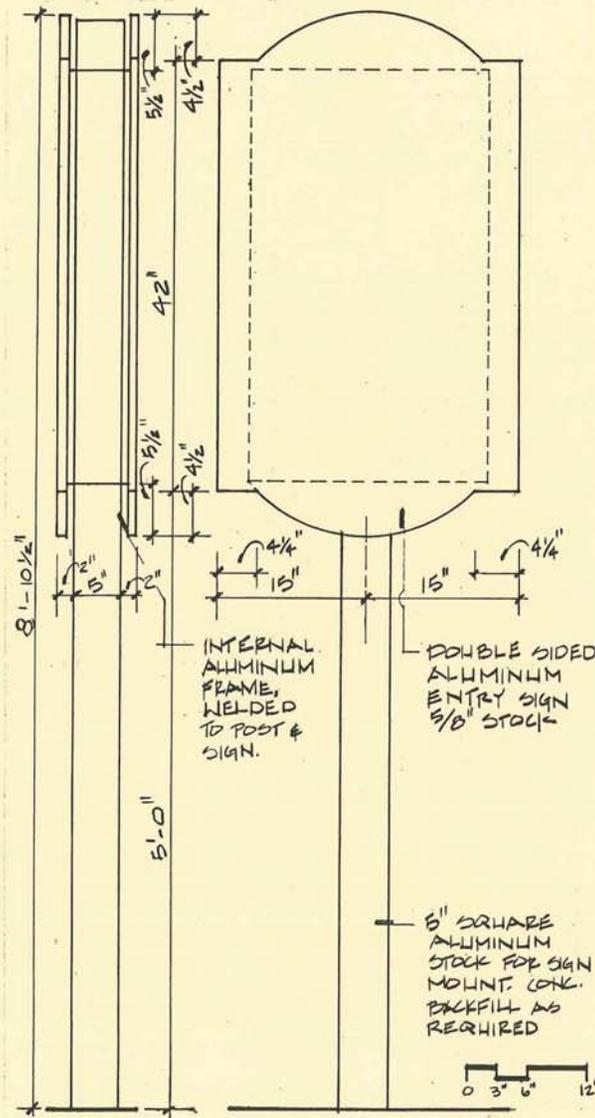
100. Park entry sign layout. (Landscapes, 1993)

The proposed permanent entry sign for the Louisville parks and parkways is of similar construction and style. This durable sign, with materials notations on the drawing, has a vertical format with a rectangular face and rounded ends. The Park Entry Sign Layout [101] shows a possible organization of information to include a logo (image to be determined, fleur de lis shown), the name of the system, the individual place name, a group of basic rules, park hours, name of original landscape architects and date of historic design. Actual lettering style is to be selected but the use of one, simple serif face is preferred with variations in letter height and use of italic text lines for the rules to provide visual separation. This sign would be used at park entries and at two (or more) points along each parkway.

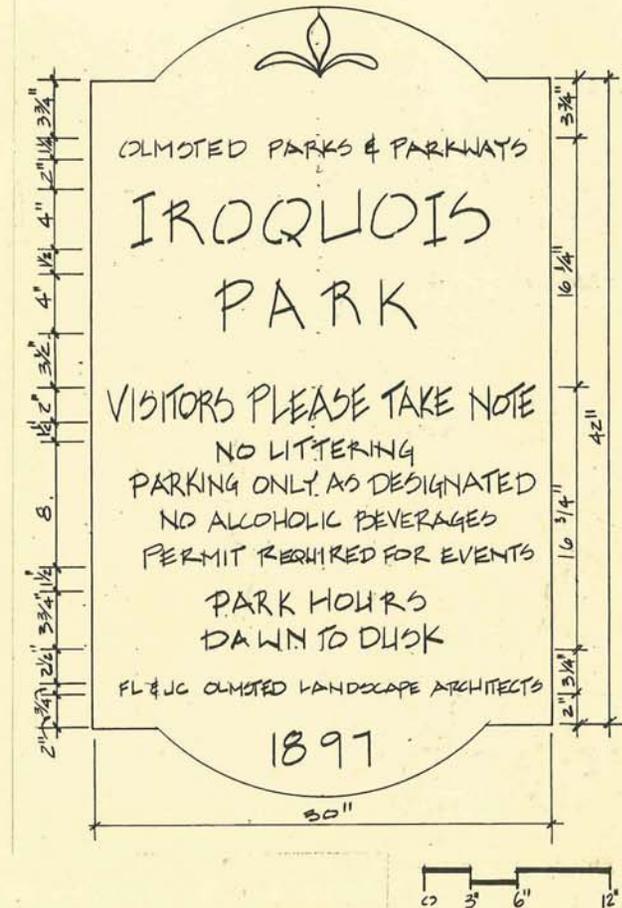
101. Park entry sign. (Landscapes, 1993)
