# Chapter 8

## The Built Landscape

Prepared by Landscapes, Westport CT

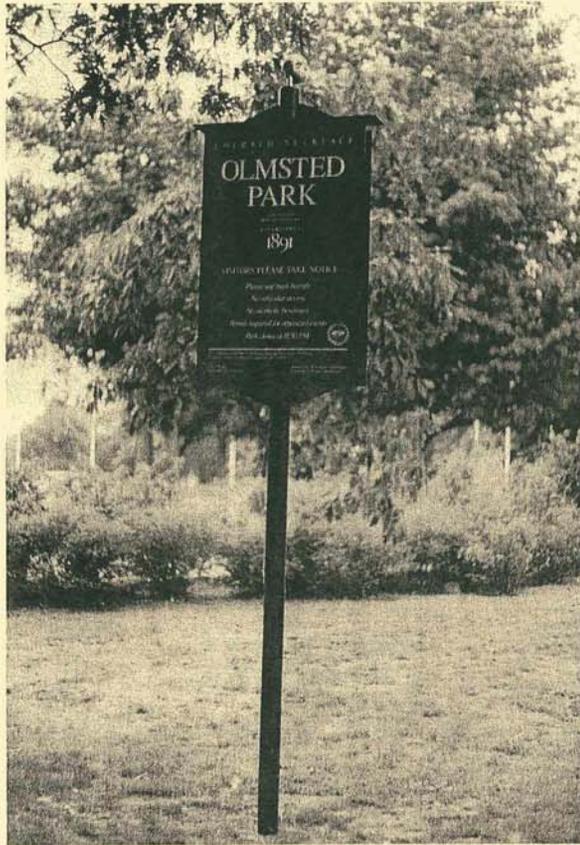
102. Olmsted Park sign from Emerald Necklace in Boston, Massachusetts, which is attractive, visible and vandal resistant. (Landscapes, 1992)

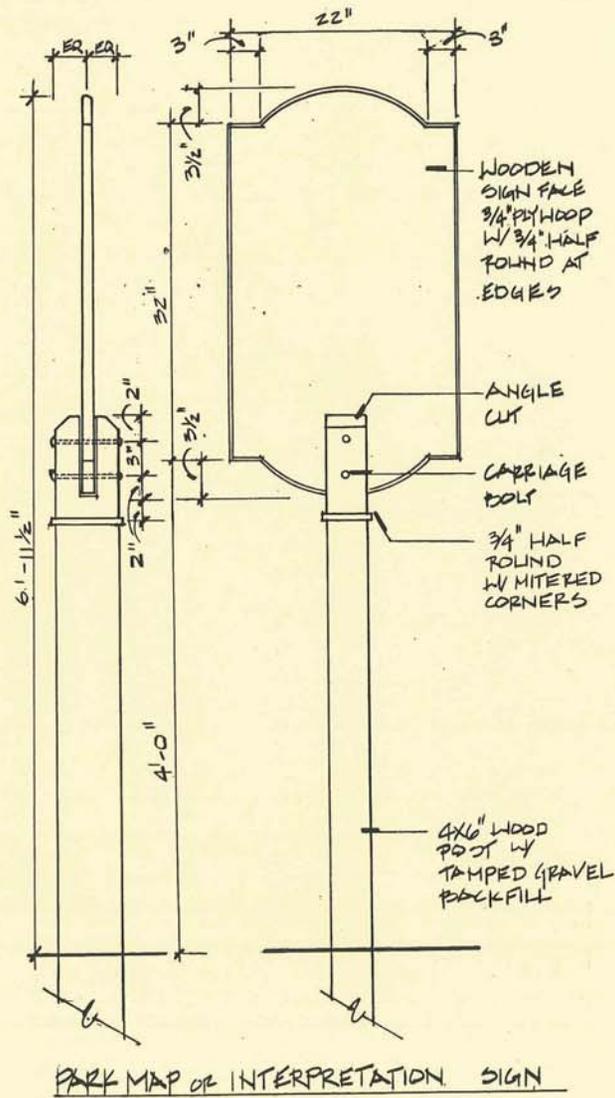
103. Park map or interpretation sign. (Landscapes, 1993)

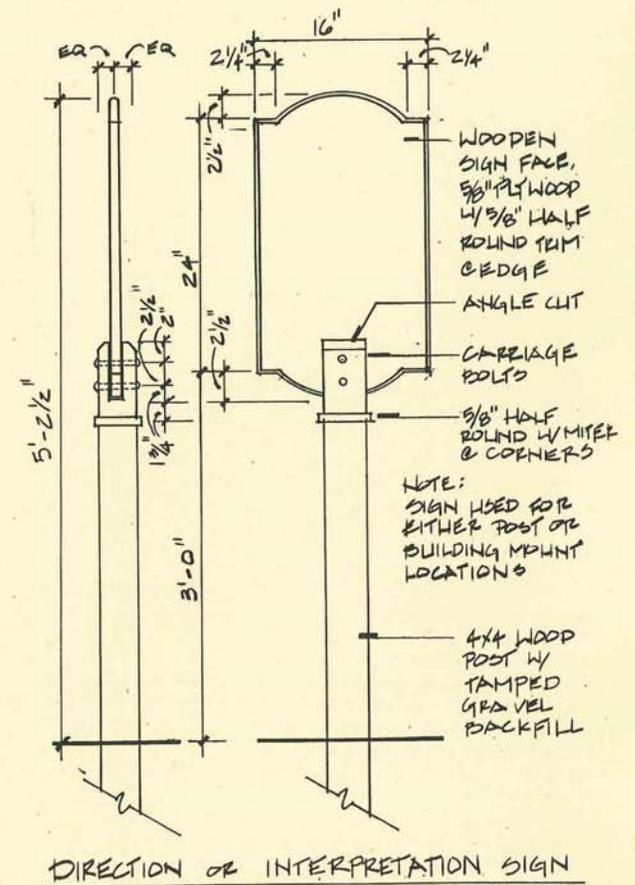
104. Direction or Interpretation sign. (Landscapes, 1993)

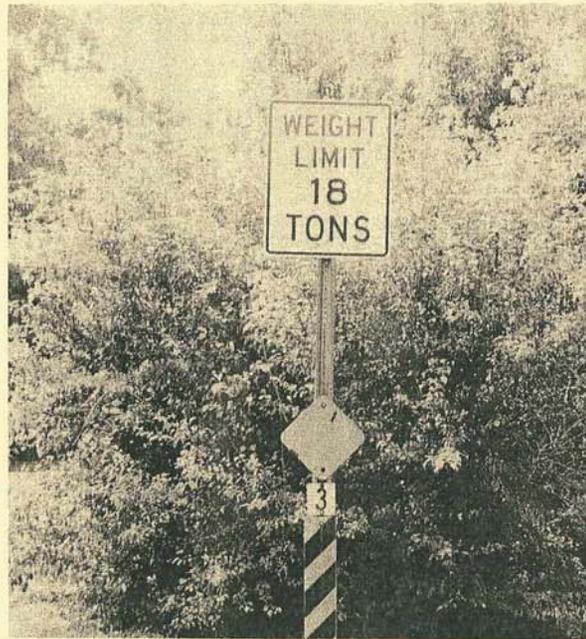
107. (Top) Painted and silkscreen plywood sign on the Boathouse at Jamaica Pond, Boston MA, which is easily constructed and repaired. (Landscapes, 1992)

108. (Bottom) Visually obtrusive metal bridge-weight limit sign along edge of drive in Cherokee Park. (Landscapes, 1993)

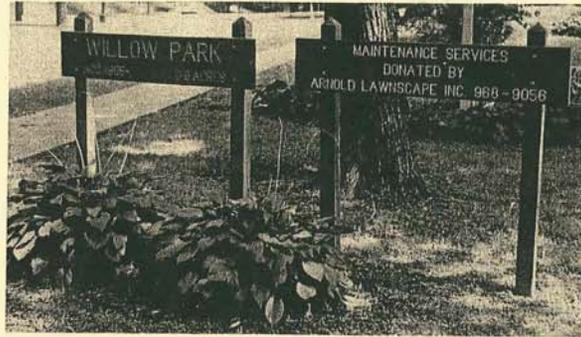
109. (Top) Wooden entrance signs for Willow Park, illustrating the problem with lack of hierarchy of information.

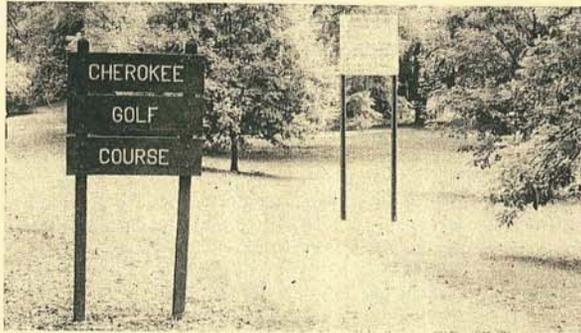
110. (Middle) Wooden place-name sign for Cherokee Golf Course located next to a metal park-rule sign that is difficult to read.

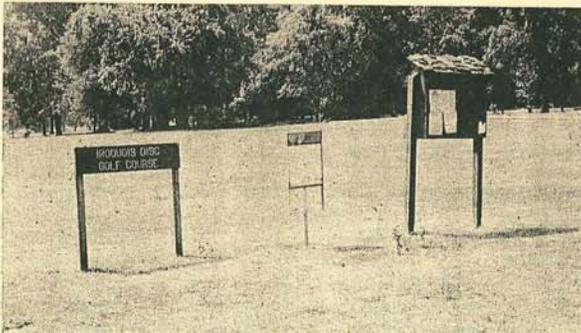
111. (Bottom) Wooden place-name sign for Iroquois Disc Golf Course located next to a hard-to-read course rules sign and a bulletin board. (Landscapes, 1993)

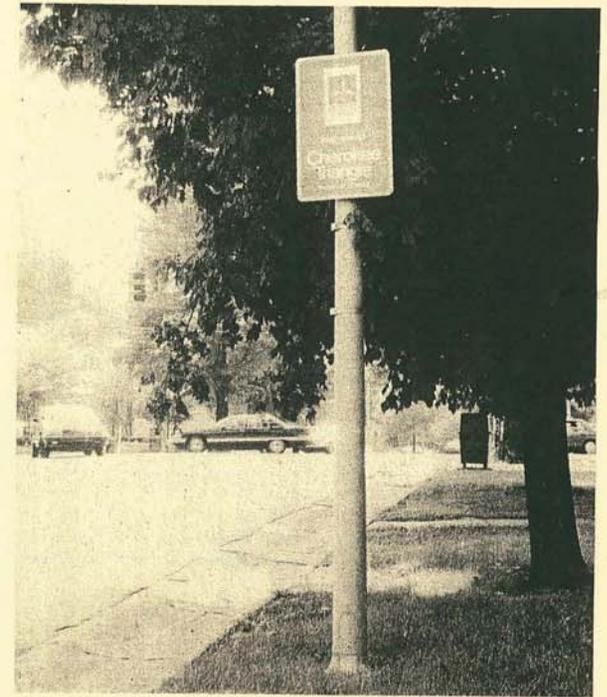
112. Metal place-name sign affixed to a metal light pole near the entrance to the Cherokee Triangle neighborhood. (Landscapes, 1993)

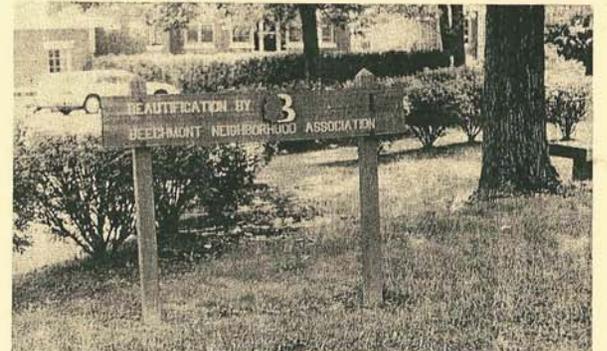
113. Wooden place-name sign for the Beechmont Neighborhood Association, which credits a beautification effort. (Landscapes, 1993)
